SD012001

SLIP MEMBER BOOT CHECK

SERVICE/TECHNICAL

DRIVESHAFT INFO

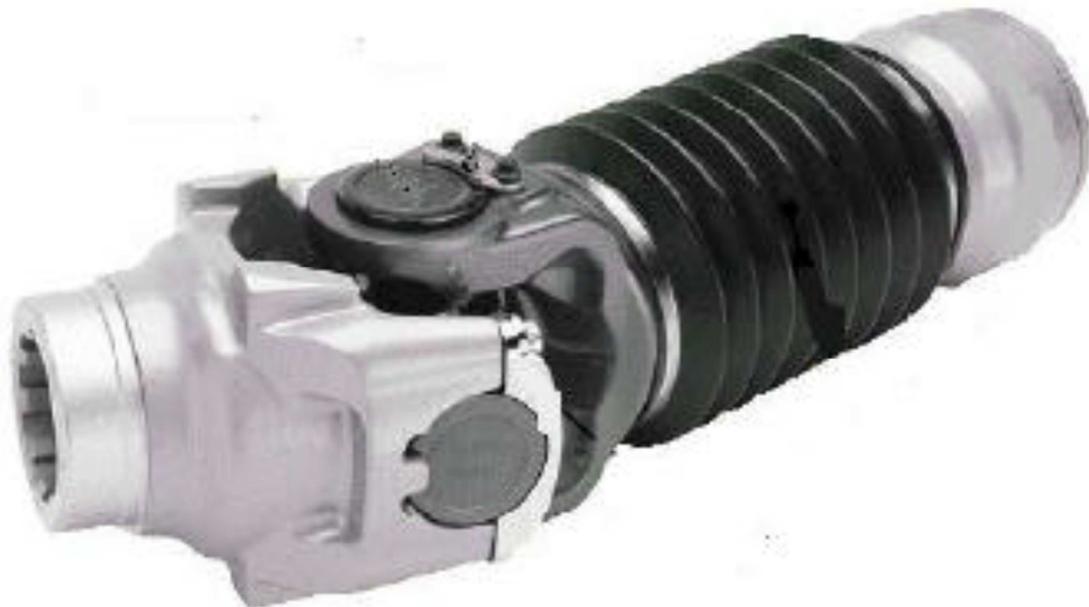
Check yoke shaft boot (pictured below) to ensure boot is properly attached to the yoke shaft and tube sleeve and no damage or looseness is apparent. Visually inspect boot for tears or punctures. Inspect boot clamps for damage. If any of these situations are evident, replacement of the slip member boot is necessary immediately.

Also inspect the yoke shaft spline surface and spline sleeve for damage. If the splines are damaged, missing, twisted or any Glidecote is missing, complete driveshaft replacement is necessary. Inspect the entire slip assembly for contaminants, if the slip assembly shows evidence of rust or the lube is severely contaminated, complete driveline replacement is necessary.

A loose or damaged slip member boot allows contaminants to invade the slip member assembly. Invasion of contaminants into the slip member assembly can degrade the lubricant and cause slip member component damage, which can result in separation of the driveline from the vehicle. A separated driveline can result in property damage, serious personal injury or death.

SPL boot kit part numbers.

SPL170 Kit 211987X

SPL250 Kit 211959X

Kit contains boot, 2 clamps and lube pack.

Boot clamp must be tensioned to 136-180Nm or 100-130LB.FT.
