### AXLE TECH BULLETIN

For Axle Models: D170, D190, D590 (not applicable for FTP versions)

#### Screen Filter Assembly removed (Forward Axle only)

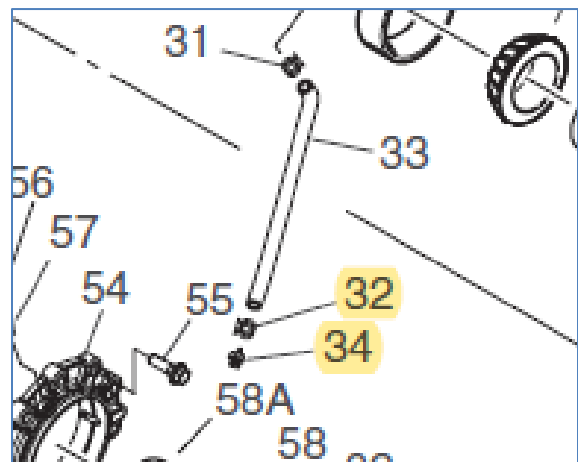
On page 7 of the Illustrated Parts List AXIP-0057A, items 32 & 34 are now no longer fitted.

As of the beginning of January 2021, the Screen Filter Assembly is no longer installed to the forward drive head (Hose remains).

**When rebuilding one of these axle units, we recommend also NOT to fit items 32 & 34 anymore.**

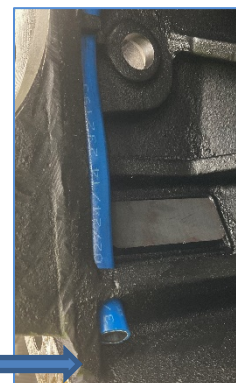
Also, on page 17 of the Service Manual AXSP-0057, install the hose as shown, but do NOT attach the screen and the hose clamp at the end.

From the 1<sup>st</sup> of January 2021 the Screen is no longer fitted.
