SUMO MD MV/HV Powertrain

SUMO MD MV/HV Powertrain Troubleshooting Guide

March 2021

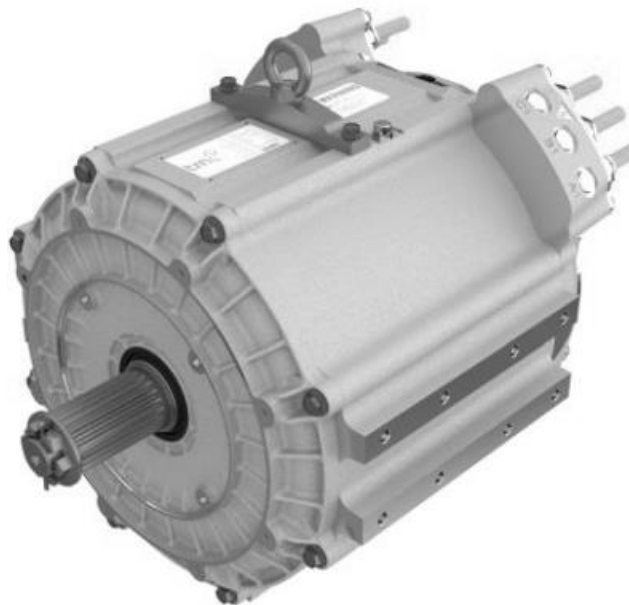
Dana TM4 Motor and MCU Components (This is an example)

Dana TM4 Motor

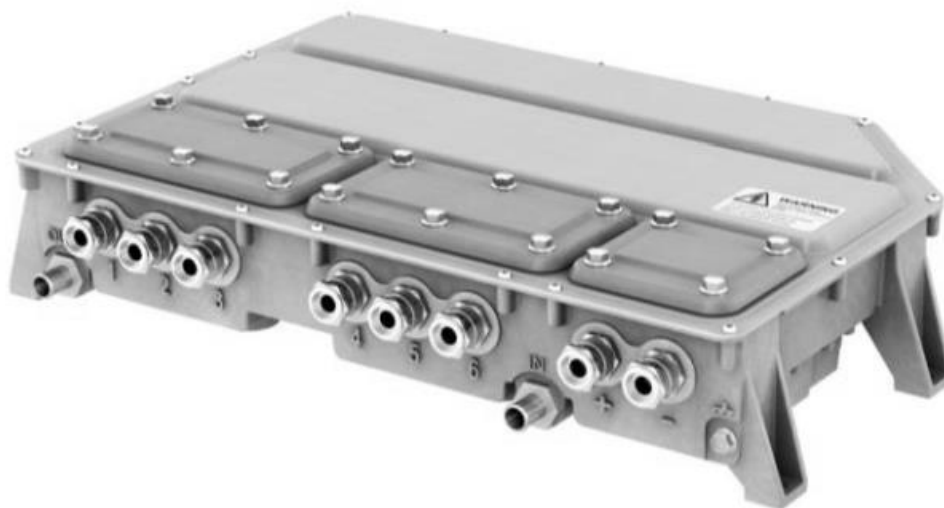
Dana TM4 MCU

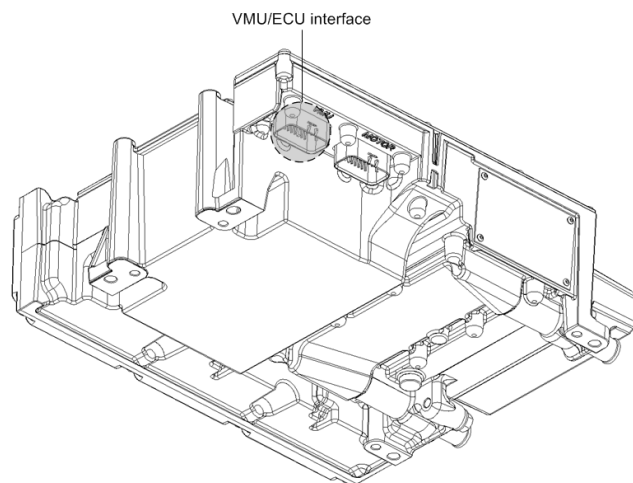
The communication connector has 23 pins with the following specification:

VMU/ECU interface harness – Plug pinout specifications 1-776228-1 (Type 2)

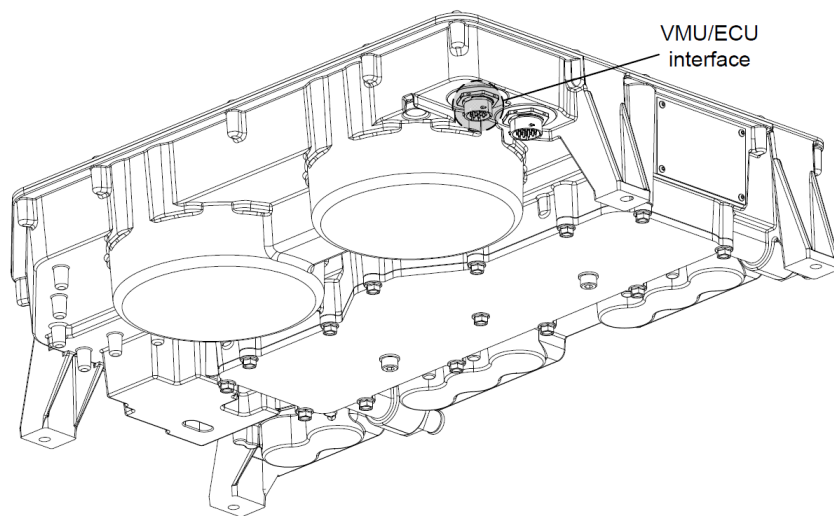
VMU/ECU interface harness – Plug pinout specifications – P770E0106 (Type1)

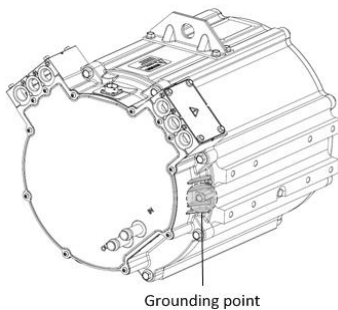
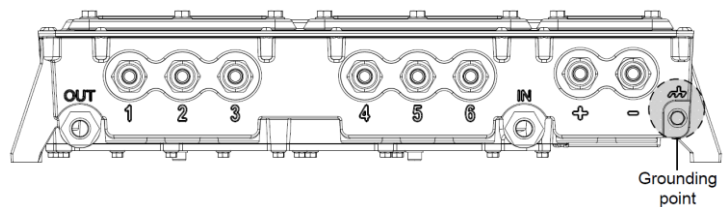
The grounding point connection prevents functional issue to the motorization system, and ensures the user safety in case of an insulation fault. An incorrectly grounded connection may result in functionality losses and safety risks for the user. Grounding straps must be connected to their dedicated connection points (on the MCU and the motor) to the vehicle chassis frame.

The vehicle chassis connection points for the MCU and motor grounding straps should ideally be the same point, or the same vehicle chassis frame side. Conductive grease should be used on each of the contact points to ensure reliable and durable grounding connections. The resistance between the grounding points and the chassis must be tested each time the connection is impacted. The resistance must be less than 0.1 Ohm.

MCU and motor grounding point locations (product type example)

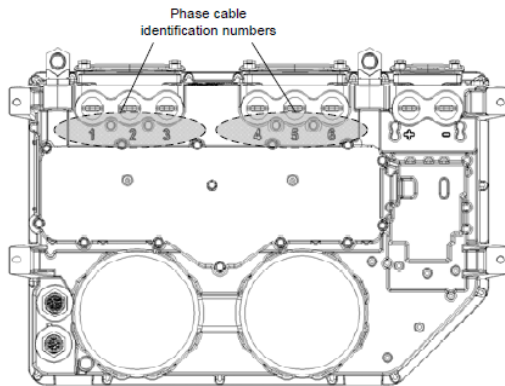
Power cables are required between the MCU and the motor to connect each phase. An example of a product with a view of the phase cable connection points is shown below.

Phase Cable Identification (90 degrees)

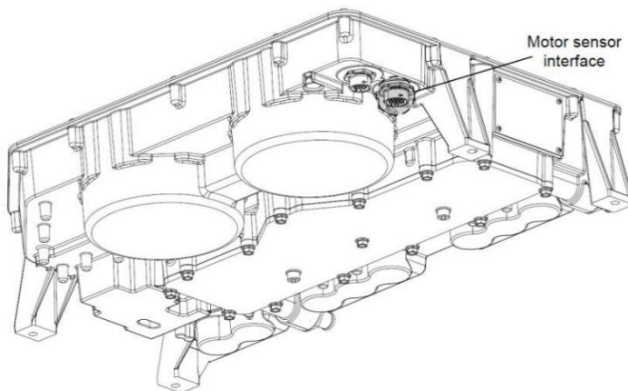
MCU connector type 1

MCU Type 1	MCU Type 2	Signal name	TM4 Motor Type 1	TM4 Motor Type 2
A	1	Temperature C-	A	F3
B	9	Temperature C+	B	F2
C	16	Temperature B-	C	A3
D	2	Temperature B+	D	A2
E	10	Temperature A-	E	A4
F	17	Temperature A+	F	B4
J	3	R1_OUT	N	A1
T	11	R2_OUT	P	B1
L	18	COS+ (S1)	L	C1
M	4	COS- (S3)	M	D1
N	12	SIN+ (S2)	J	E1
P	19	SIN- (S4)	T	F1
H	5	HVIL_TO_MOTOR	H	F4
R	13	1 Wire OUT	R	C2
S	20	1 Wire GROUND	S	C3
K	6	HVIL_FROM_MOTOR	K	E4
V	N/C	Chassis	V	N/C

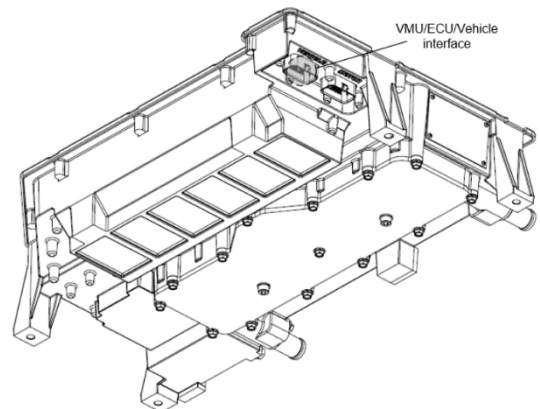
MCU connector type 2

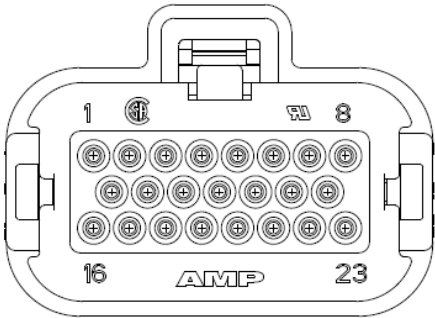
Dana TM4 MCU A3 (Type 2)

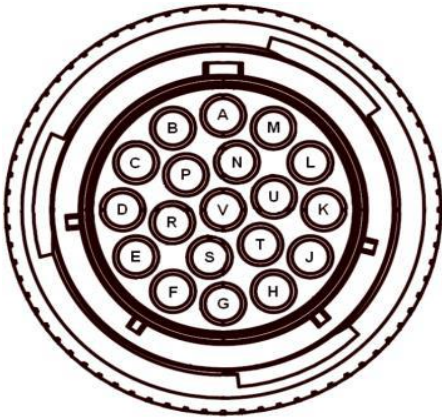
Dana TM4 MCU A1/A2 (Type 1)

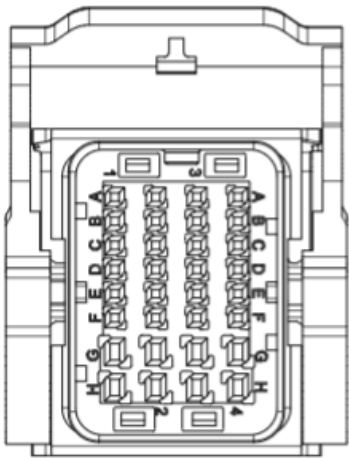
Dana TM4 Motor (Type 2)

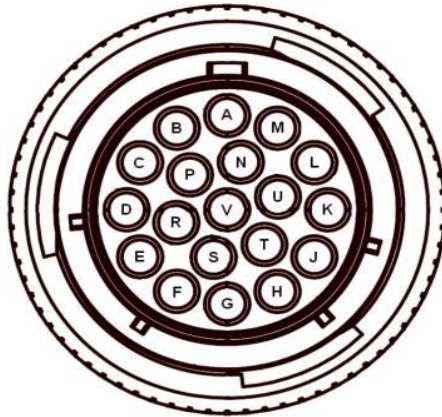
Dana TM4 motor (Type 1)

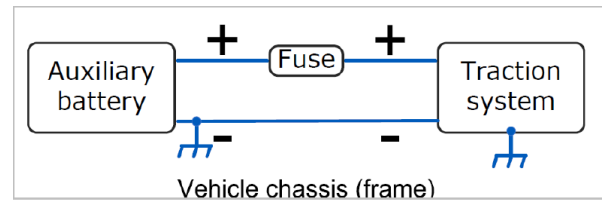
To protect the system against short circuit, a fuse is connected in series with the positive terminal of the auxiliary battery.

Specifications	Units	Values (12 V)	Values (24 V)
Maximum MCU steady state current	A	4.5	3
Maximum MCU inrush current	A	< 10	< 10
Maximum MCU quiescent current	mA	< 1	< 1.5

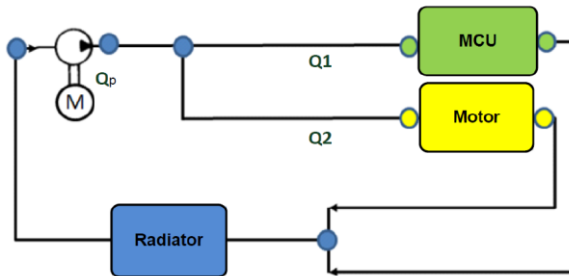
The motor and the MCU are linked to the cooling system by a fan/pump/coolant tank and radiator configuration. There are two possible configurations for the cooling system: the parallel configuration and serial configuration.

Parallel Configuration

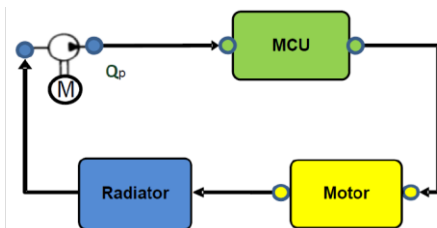
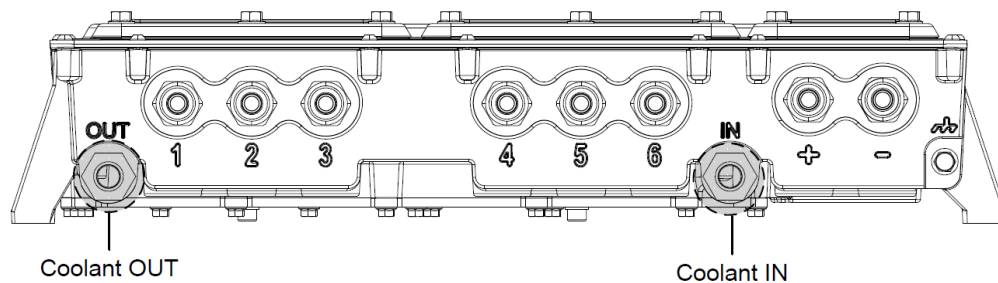
Serial Configuration

MCU example with coolant inlet and outlet indications

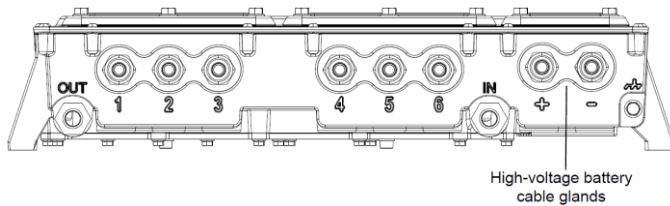
The figures below show an example of an MCU cable gland where the High Voltage battery (Traction Battery) is connected.

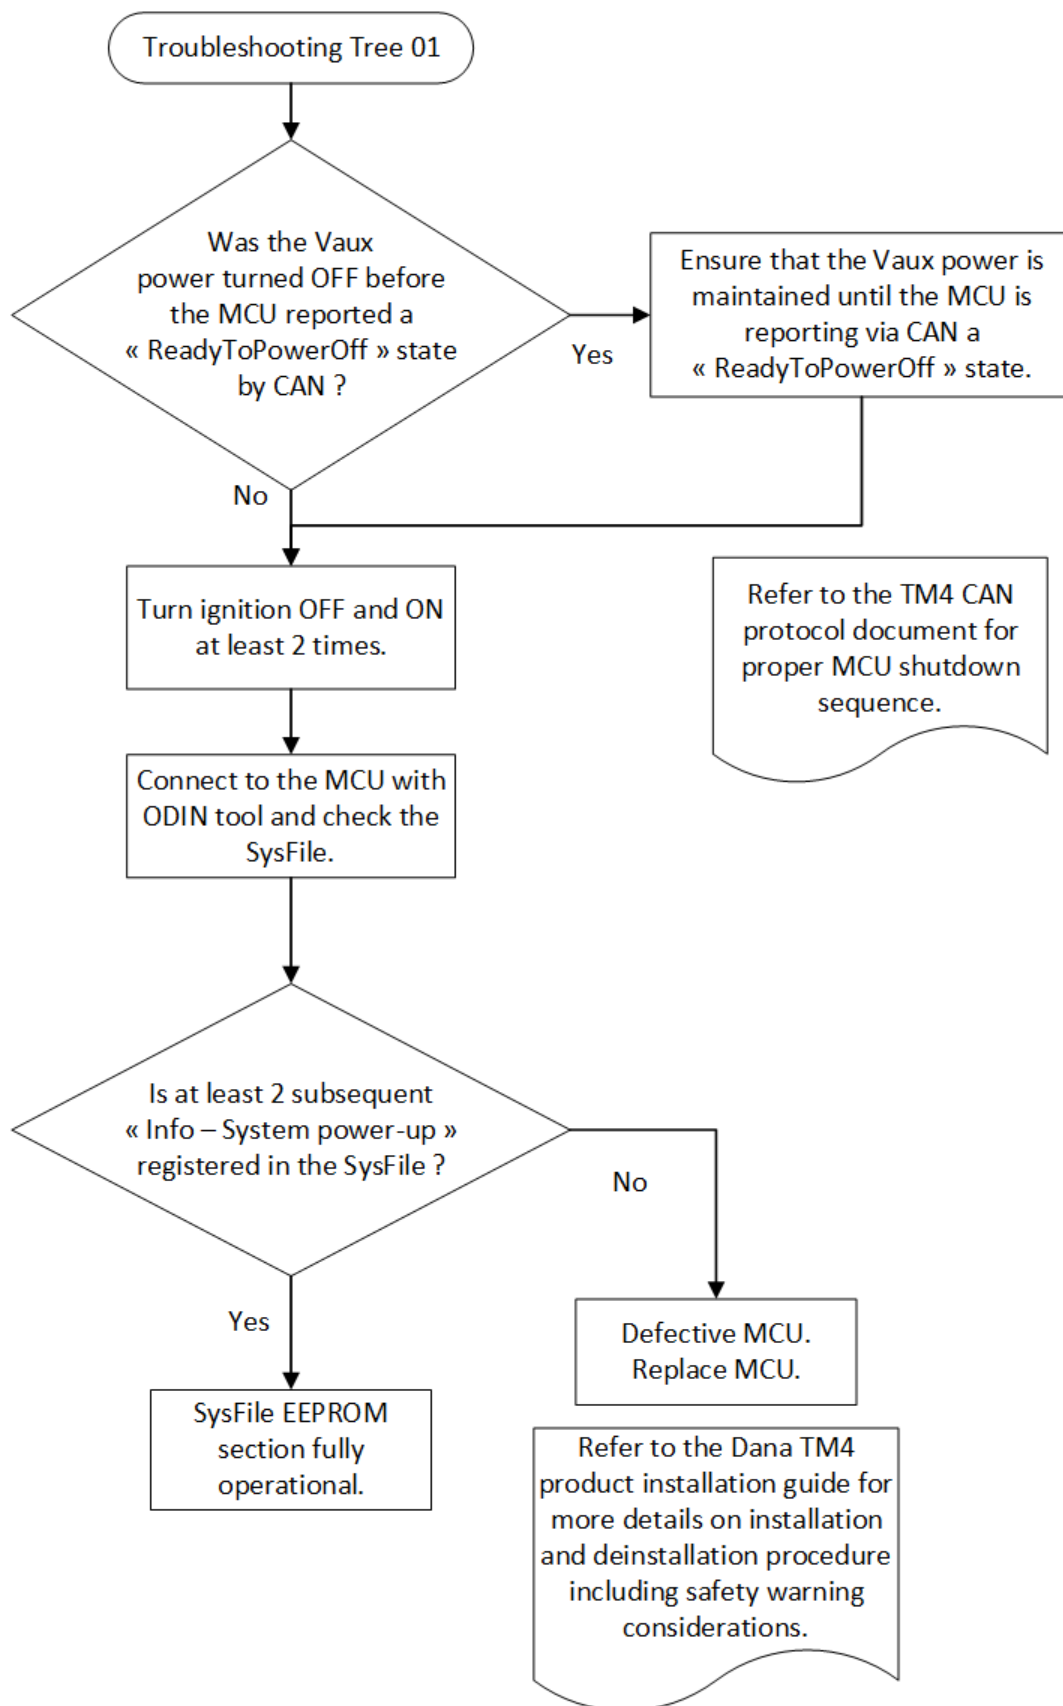
To correctly diagnose the faulty system, connect the Diagnostic Tool (see «Diagnostics» section for test equipment and descriptions) and follow the troubleshooting tree procedure below.

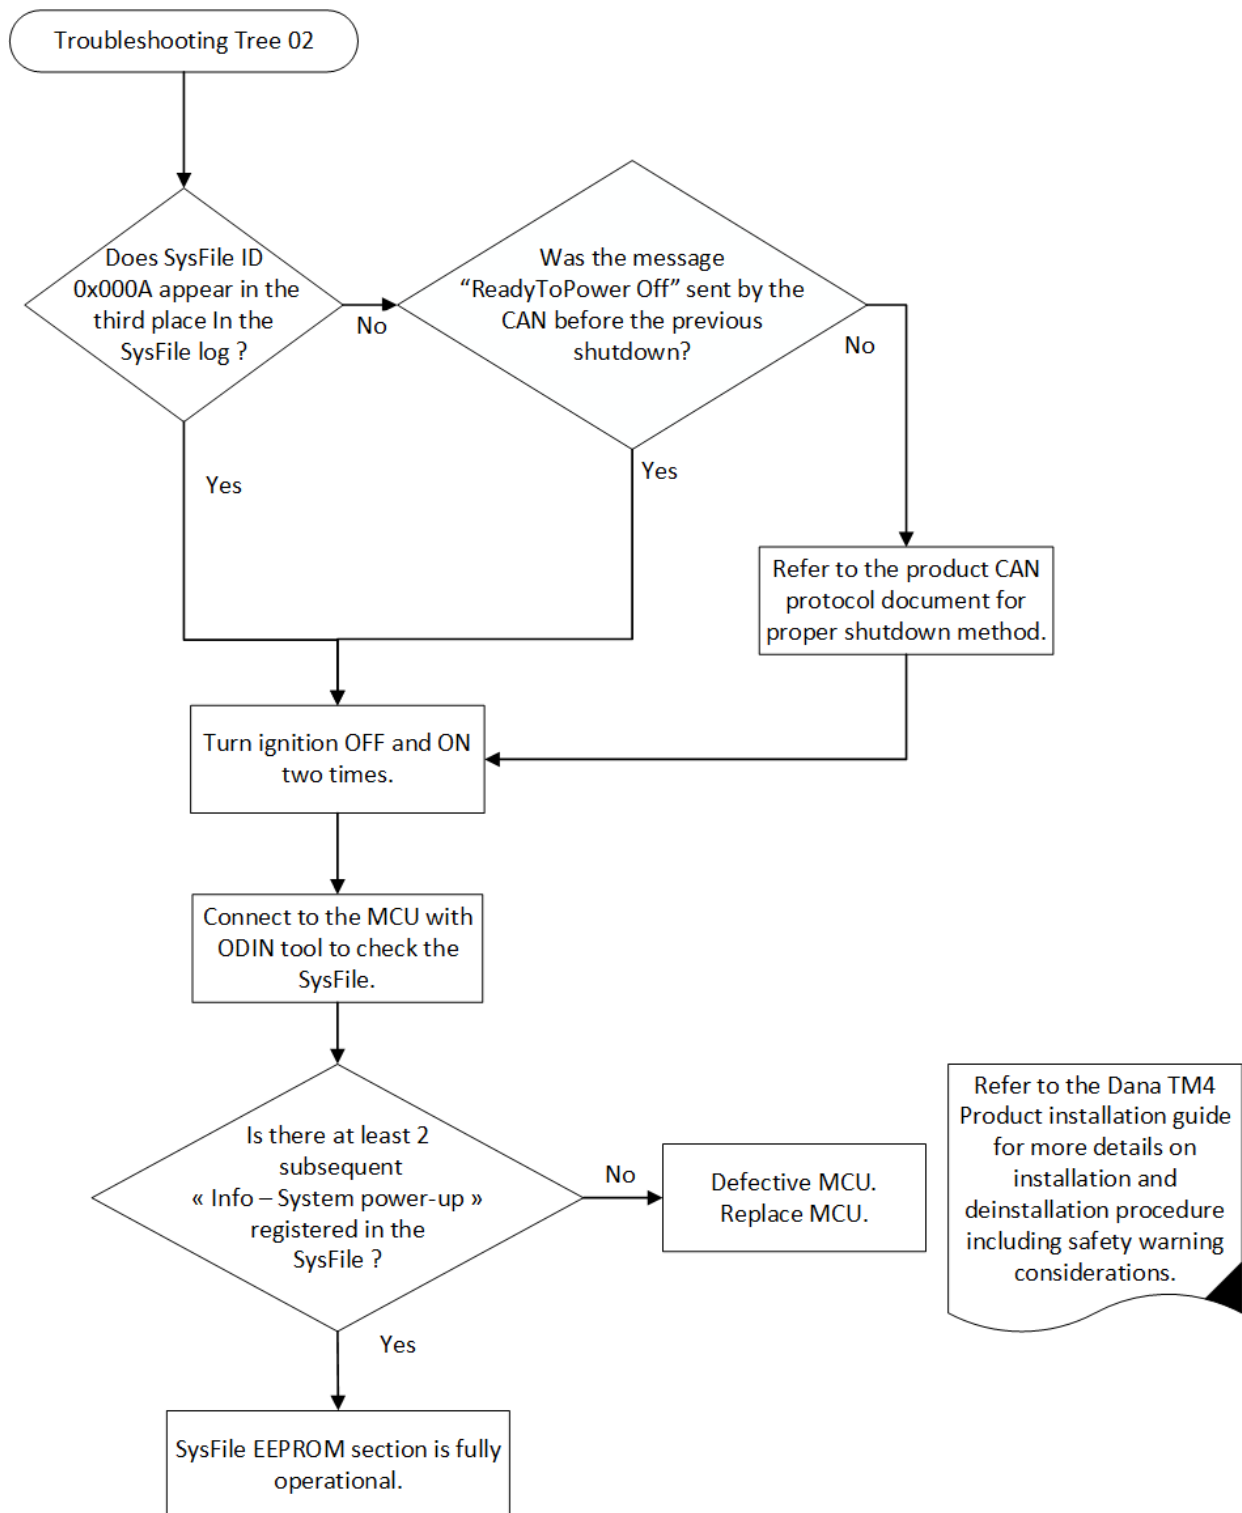
The TT02 call the following process:

- Appendix 3: Save EEPROM Sections.

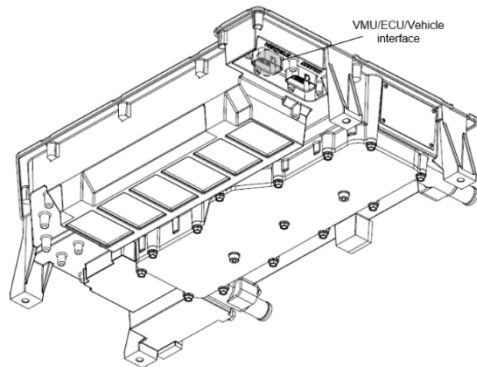
VMU/ECU Interface (Type 2)

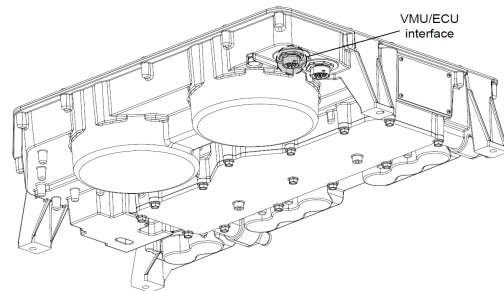
VMU/ECU Interface (Type 1)

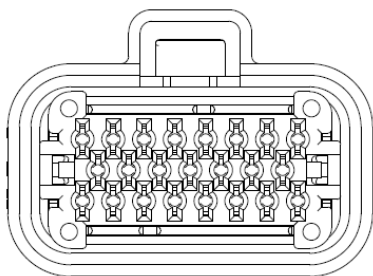
VMU/ECU interface harness Plug Pinout (Type 2)

Connector (Front) (Type 2)

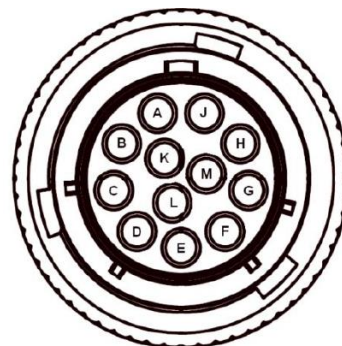
VMU/ECU interface harness Plug Pinout (Type1)

Connector (Front) (Type 1)

Pin	Signal names
E	V _{AUX} +
F	
L	V _{AUX} -(Chassis)
M	
G	IGNITION
A	CAN1L
B	CAN1H
C	CAN2L
D	CAN2H
J	HVIL
K	HVIL
H	Emergency stop

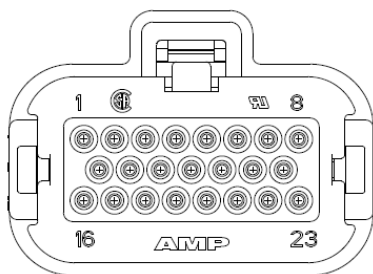
Wire Insertion Side (Back) (Type 2)

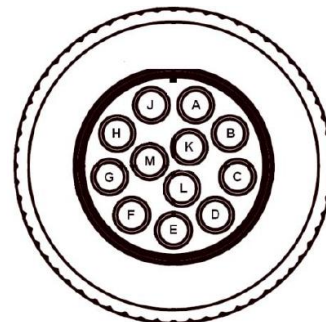
Wire Insertion Side (Back) (Type 1)

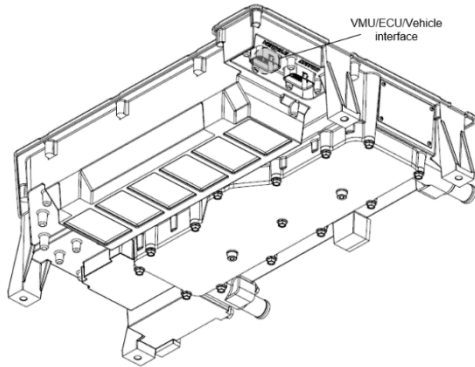
VMU/ECU Interface (Type 2)

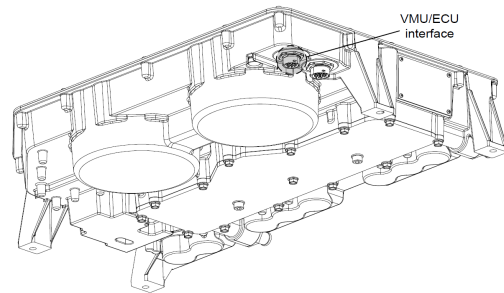
VMU/ECU Interface (Type 1)

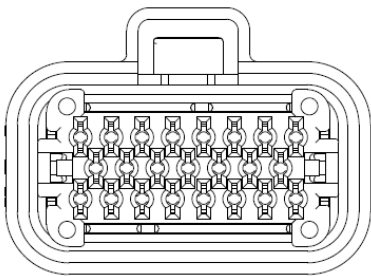
VMU/ECU interface harness Plug Pinout (Type 2)

Connector (Front) (Type 2)

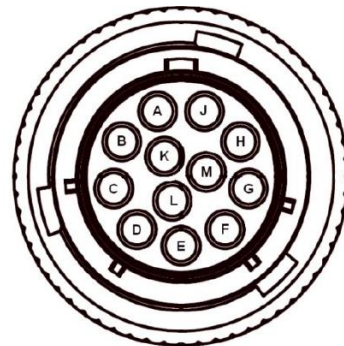
VMU/ECU interface harness Plug Pinout (Type1)

Connector (Front) (Type 1)

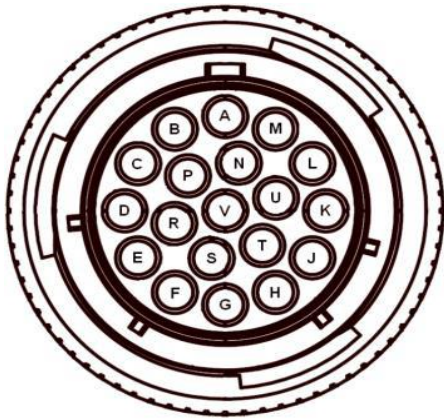
TM4 Motor connector (Type 1)

Signal name	TM4 Motor connector pinout Type 1	TM4 Motor connector pinout Type 2
Temperature C-	A	F3
Temperature C+	B	F2
Temperature B-	C	A3
Temperature B+	D	A2
Temperature A-	E	A4
Temperature A+	F	B4
R1_OUT	N	A1
R2_OUT	P	B1
COS+ (S1)	L	C1
COS- (S3)	M	D1
SIN+ (S2)	J	E1
SIN- (S4)	T	F1
HVIL_TO_MOTOR	H	F4
1 Wire OUT	R	C2
1 Wire GROUND	S	C3
HVIL_FROM_MOTOR	K	E4

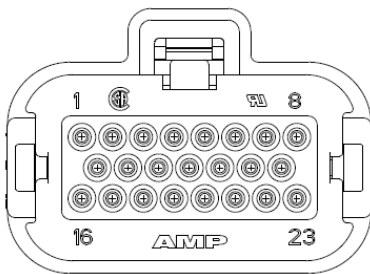
Wire Insertion Side (Back) (Type 2)

Pin	Signal names
15	V _{AUX} +
8	
22	V _{AUX} -
23	
1	IGNITION
9	CAN1L
16	CAN1H
2	CAN2L
10	CAN2H
18	HVIL_IN
19	HVIL_OUT
5	ANALOG1
13	ANALOG3
20	ANALOG2
6	DIGITAL INPUT 1
14	DIGITAL INPUT 3
21	DIGITAL INPUT 2
7	HS_OUT
17	GND_SENSORS
3	CAN_SHIELD
11	5V_SENSOR
4	PWM1_OUT
12	PWM2_OUT

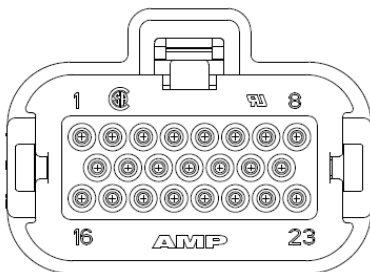
Wire Insertion Side (Back) (Type 2)

Pin	Signal names
15	V _{AUX} +
8	
22	V _{AUX} -
23	
1	IGNITION
9	CAN1L
16	CAN1H
2	CAN2L
10	CAN2H
18	HVIL_IN
19	HVIL_OUT
5	ANALOG1
13	ANALOG3
20	ANALOG2
6	DIGITAL INPUT 1
14	DIGITAL INPUT 3
21	DIGITAL INPUT 2
7	HS_OUT
17	GND_SENSORS
3	CAN SHIELD
11	5V_SENSOR
4	PWM1_OUT
12	PWM2_OUT

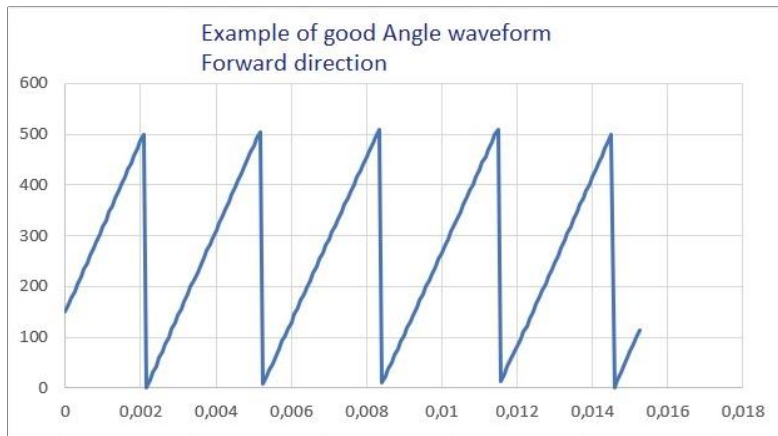
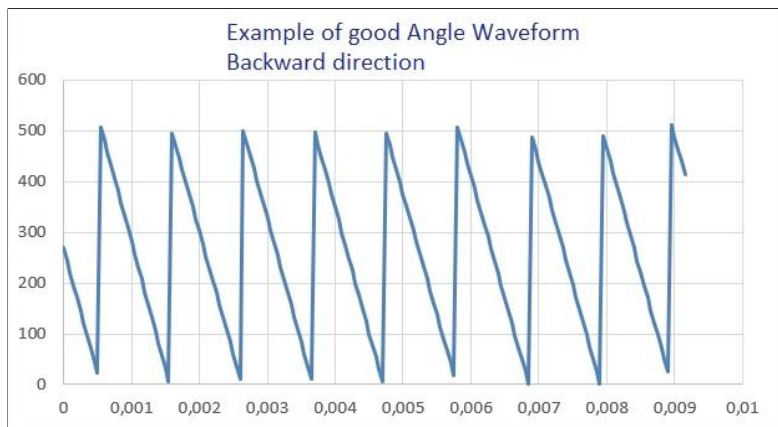
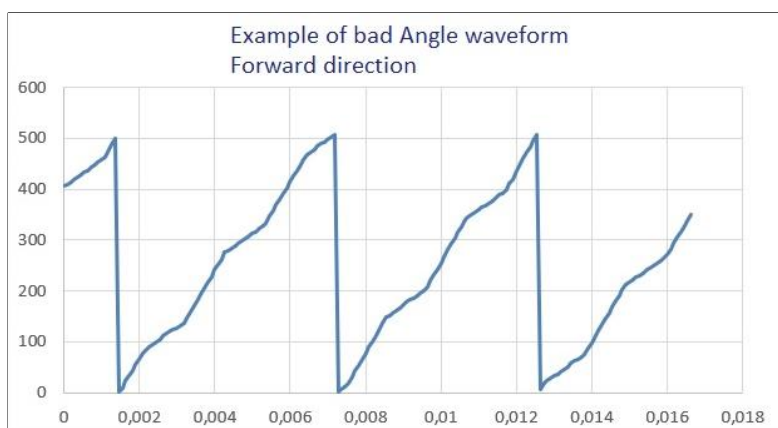
The BlackBox can then be consulted via ODIN tool to see if the angle waveform (saw tooth) is straight on each rising and falling edges.

See below examples of waveform.

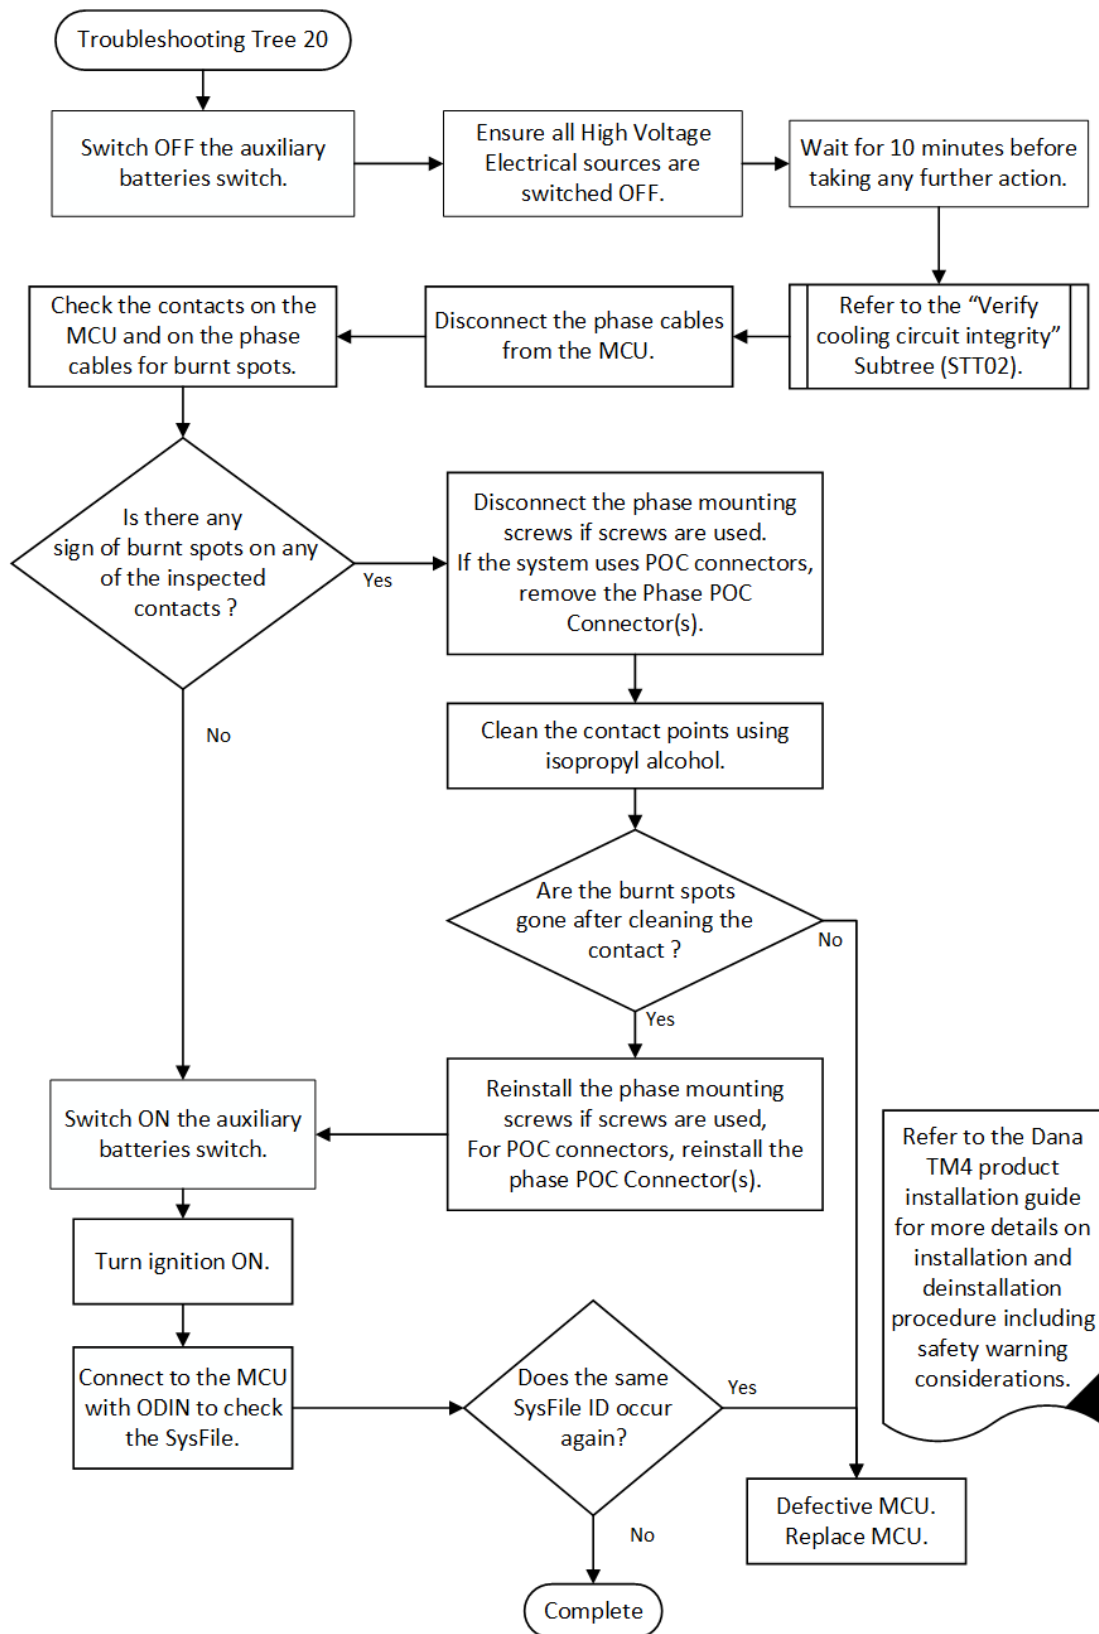
TT20: IGBT Temperature Sensor reading over the limit

The Troubleshooting Tree 20 indicates an error where one of the temperature sensors had a reading where the temperature was higher than the allowed maximum temperature and causes MCU defective state.

To correctly diagnose the faulty system, connect the Diagnostic Tool (see «Diagnostics» section for test equipment and descriptions) and follow the troubleshooting tree procedure below.

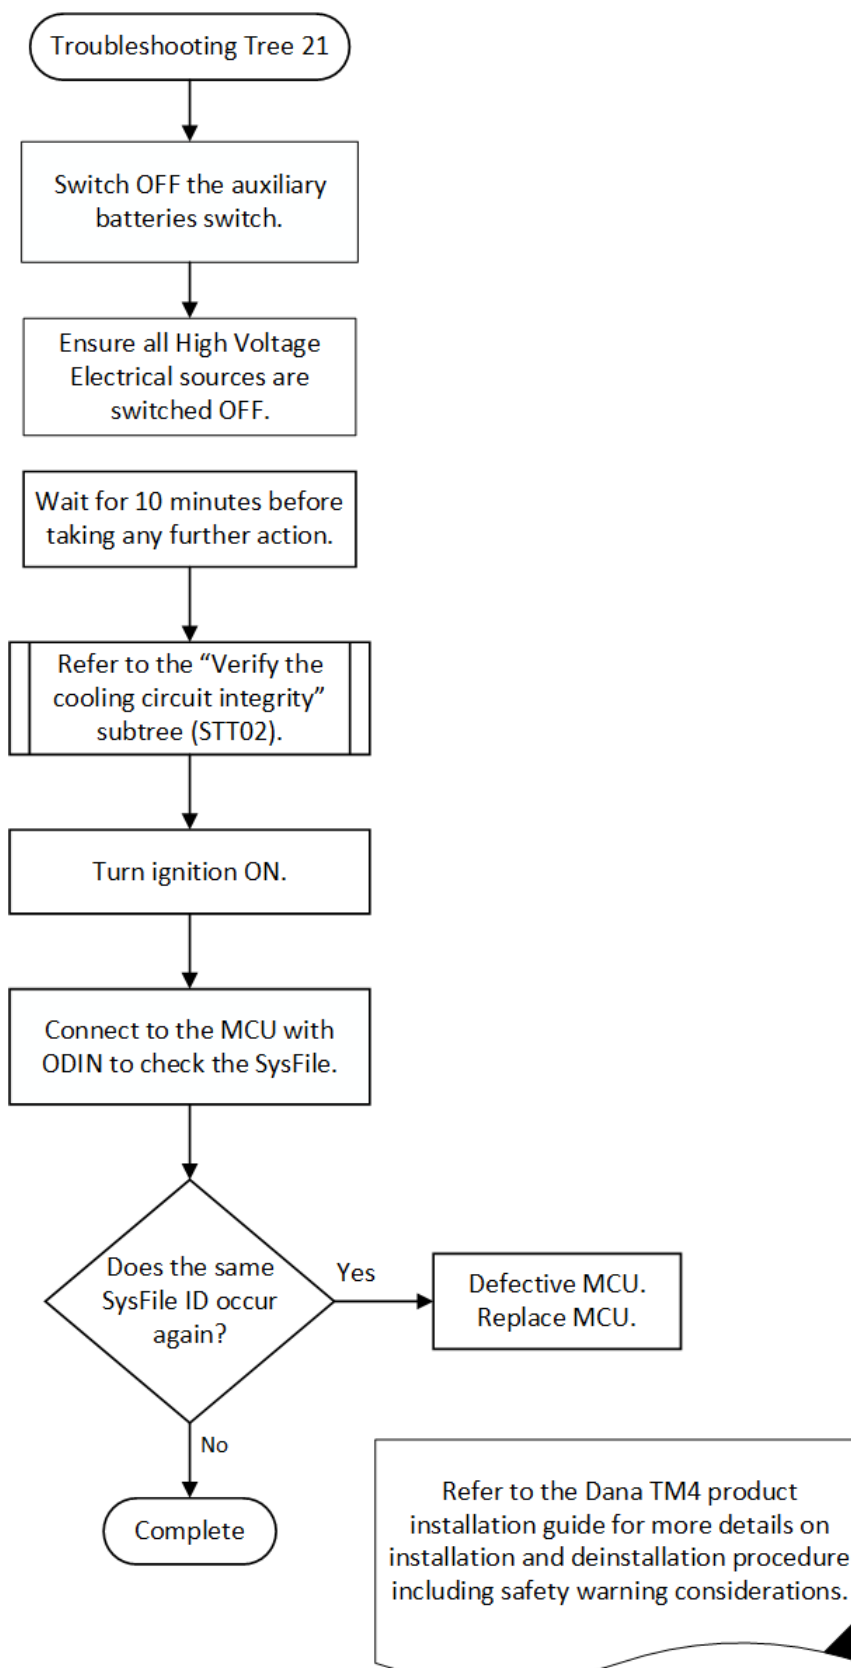
TT21: Temperature Sensor reading over the limit

The Troubleshooting Tree 21 indicates an error where one of the temperature sensors had a reading where the temperature was higher than the maximum limit and causes MCU defective state.

To correctly diagnose the faulty system, connect the Diagnostic Tool (see «Diagnostics» section for test equipment and descriptions) and follow the troubleshooting tree procedure below.

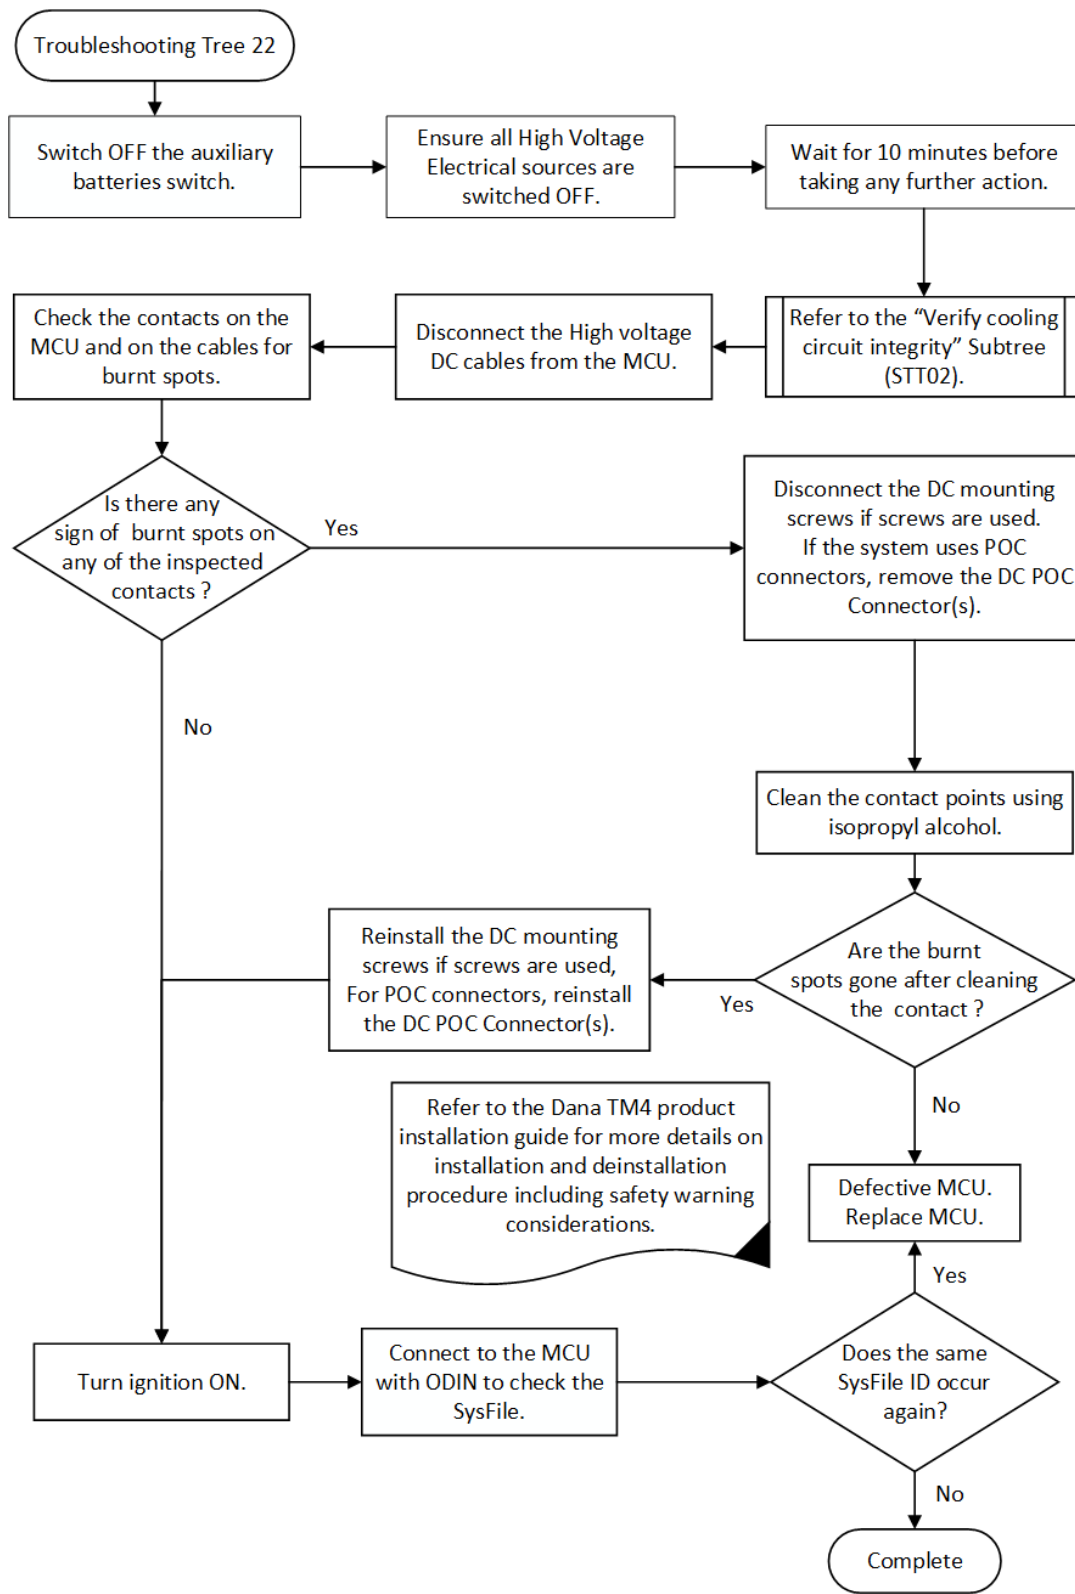
TT22: EMI Temperature measurement over limit

The Troubleshooting Tree 22 indicates an error where an internal temperature sensor had a reading which was greater than the limit, and causes MCU defective state.

To correctly diagnose the faulty system, connect the Diagnostic Tool (see «Diagnostics» section for test equipment and descriptions) and follow the troubleshooting tree procedure below.

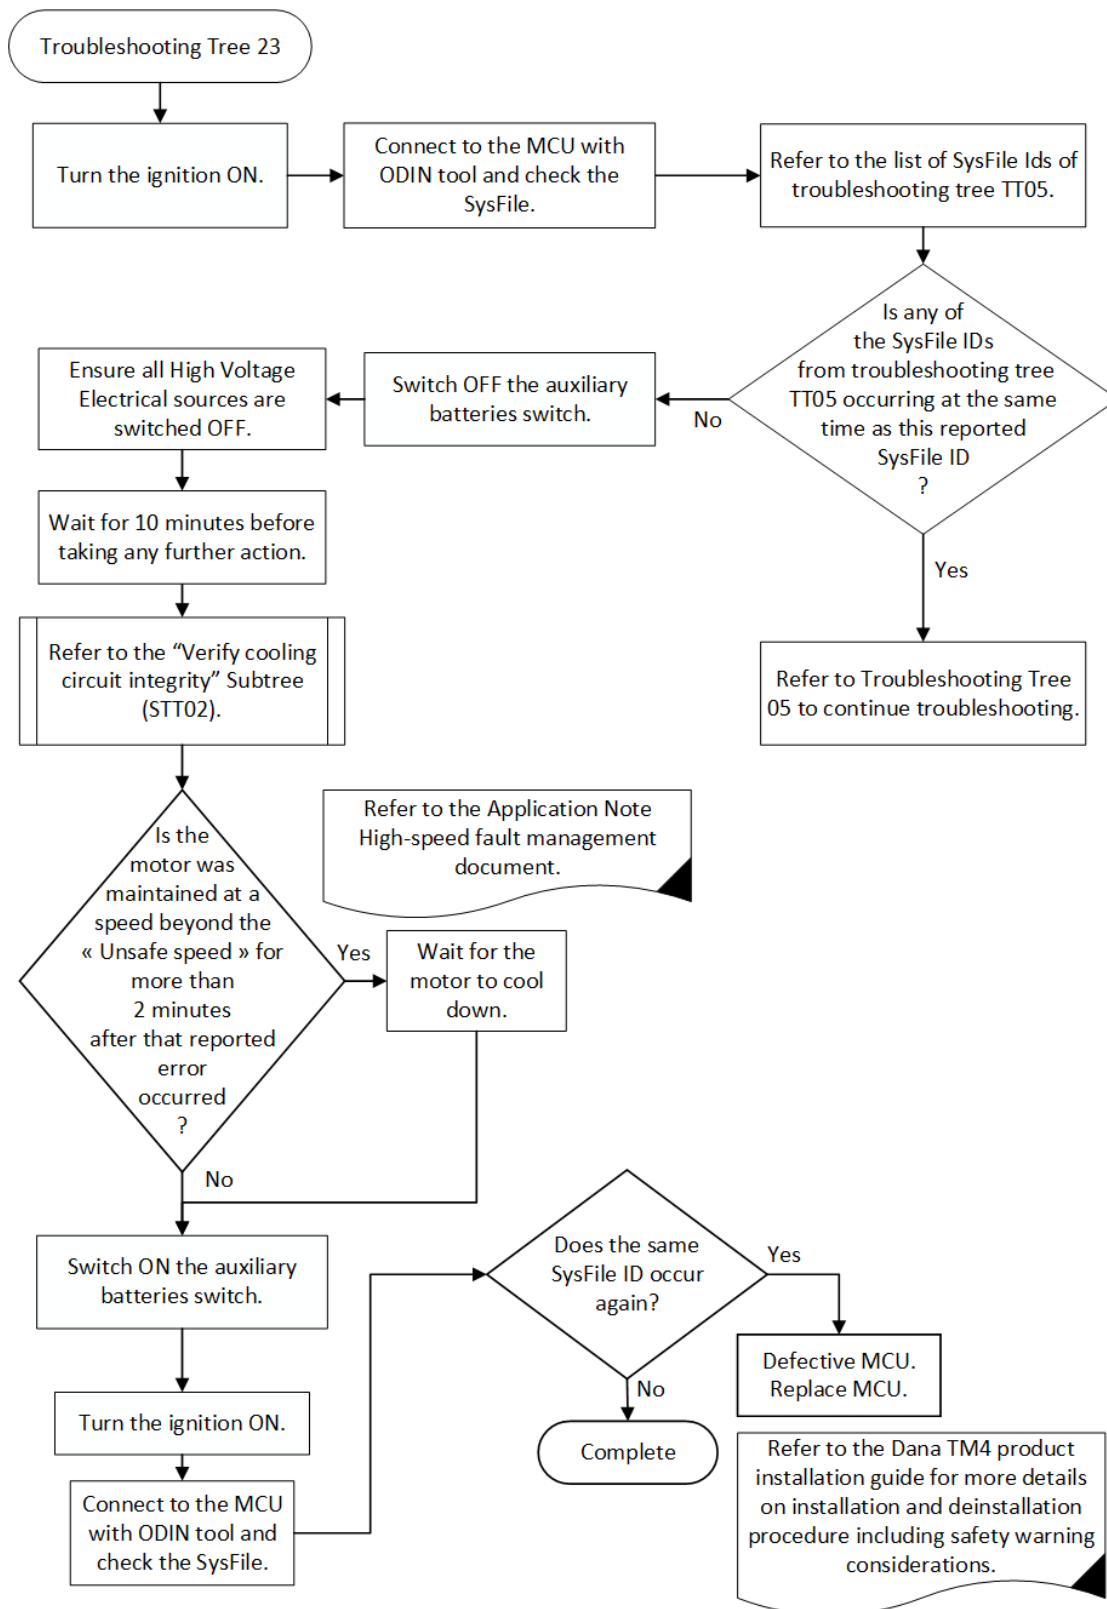
TT23: Motor Coil Temperature Sensor measurement over limit

The Troubleshooting Tree 23 indicates an error where one of the temperature sensors of the motor coil had a reading where the temperature was greater than the maximum limit and causes MCU defective state.

To correctly diagnose the faulty system, connect the Diagnostic Tool (see «Diagnostics» section for test equipment and descriptions) and follow the troubleshooting tree procedure below.

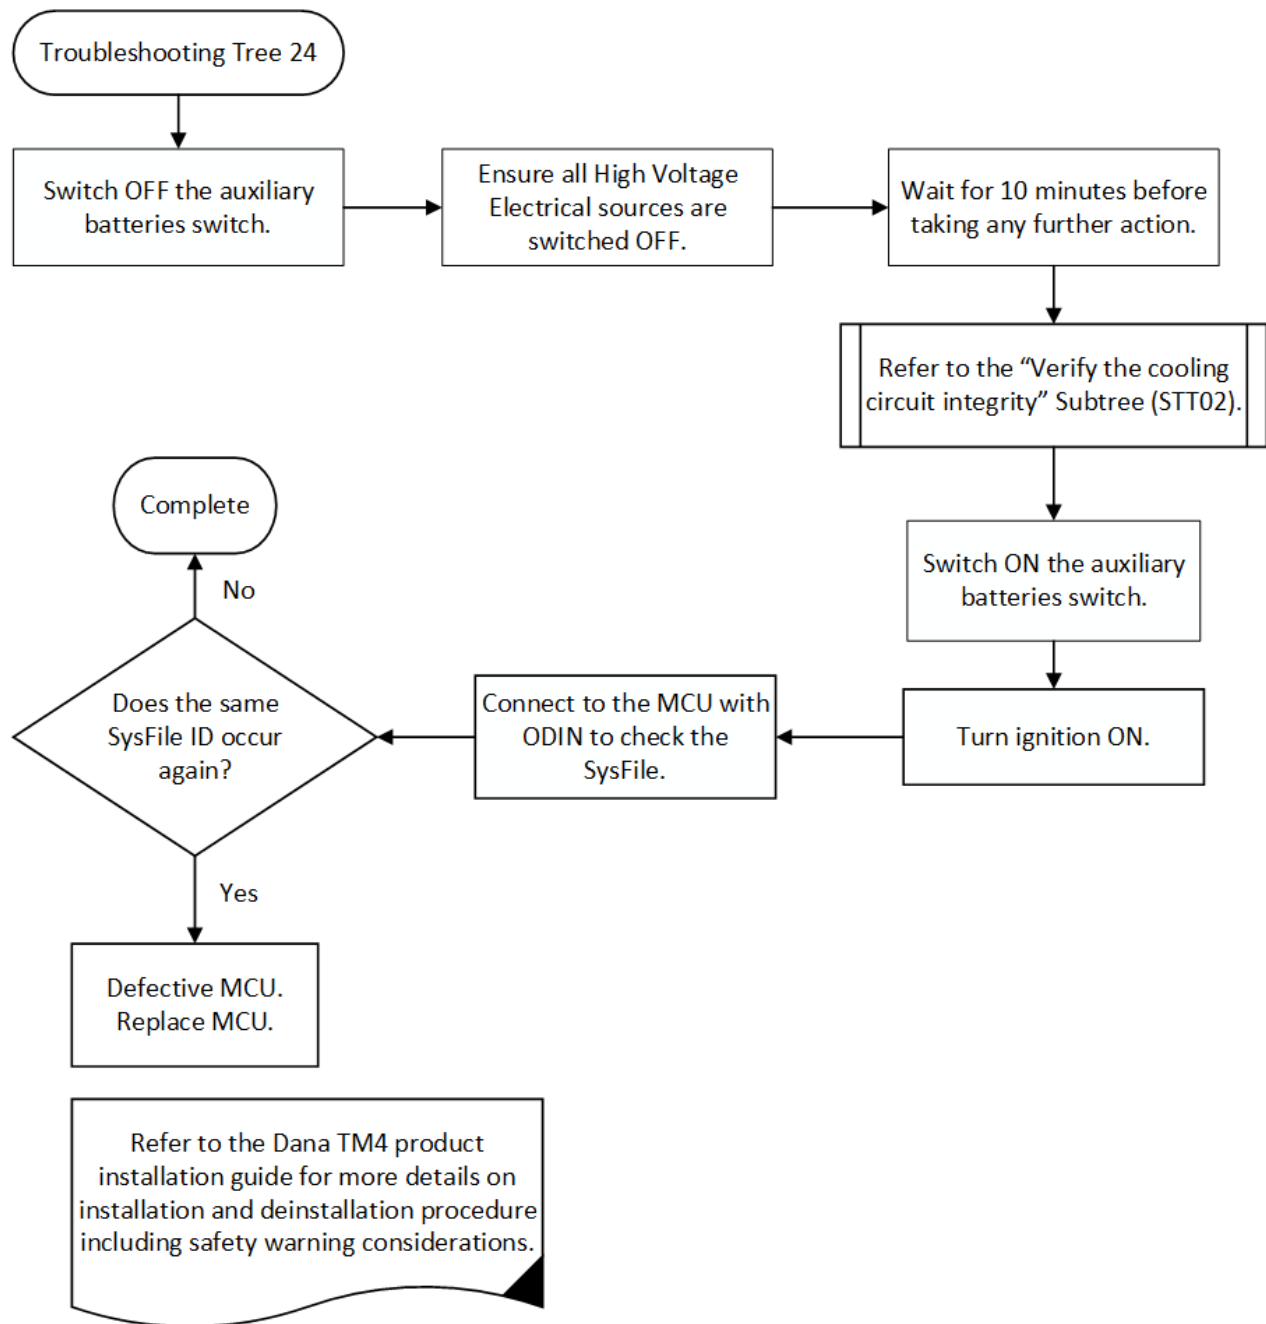
TT24: High Resolver Temperature

The Motor and MCU cooling circuit is a possible cause of this SysFile ID. If this is the case, refer to the Sub Troubleshooting Tree STT02 to verify the cooling circuit integrity of the motor and MCU cooling circuit.

To correctly diagnose the faulty system, connect the Diagnostic Tool (see «Diagnostics» section for test equipment and descriptions) and follow the troubleshooting tree procedure below.

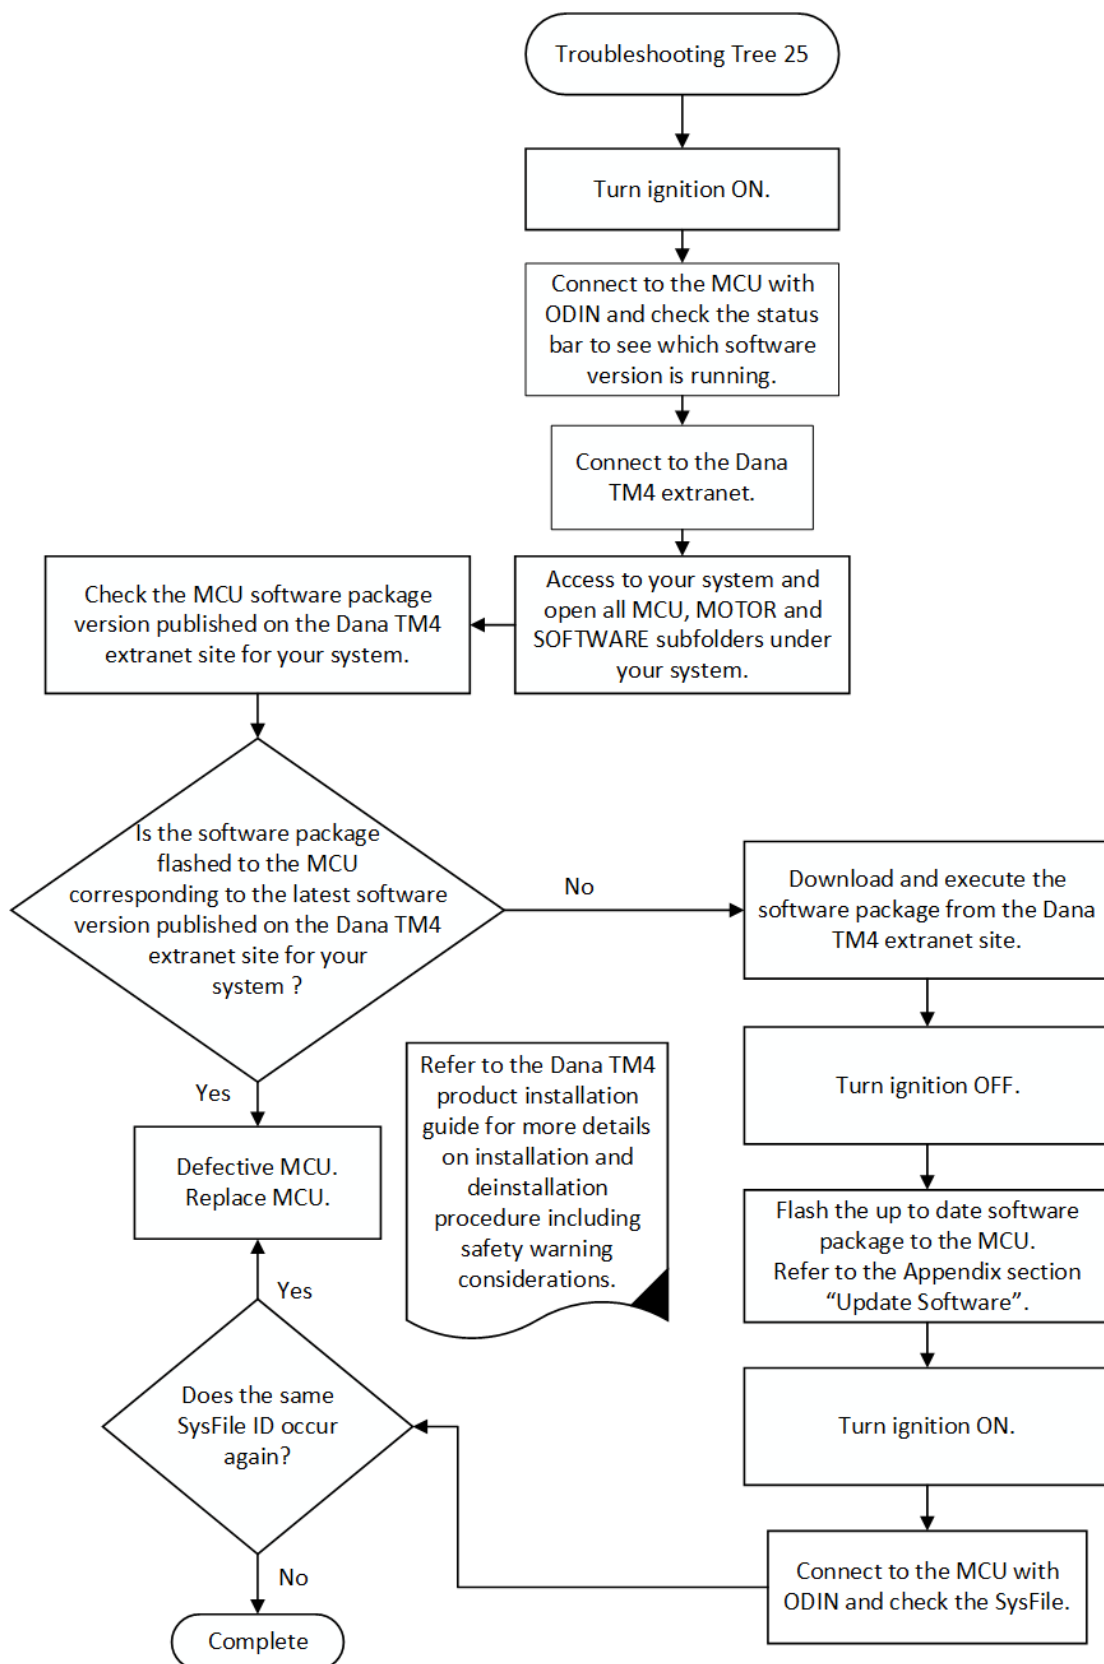
TT25: Internal Software Command Not Received Properly

These SysFile IDs is a software version issue. The user must update the software of the MCU to the last version published in Dana TM4 extranet. The MCU itself may also be defective.

The TT25 call the following process:
