SUMO MD MV/HV Powertrain

SUMO MD MV/HV Powertrain Troubleshooting Guide

March 2021

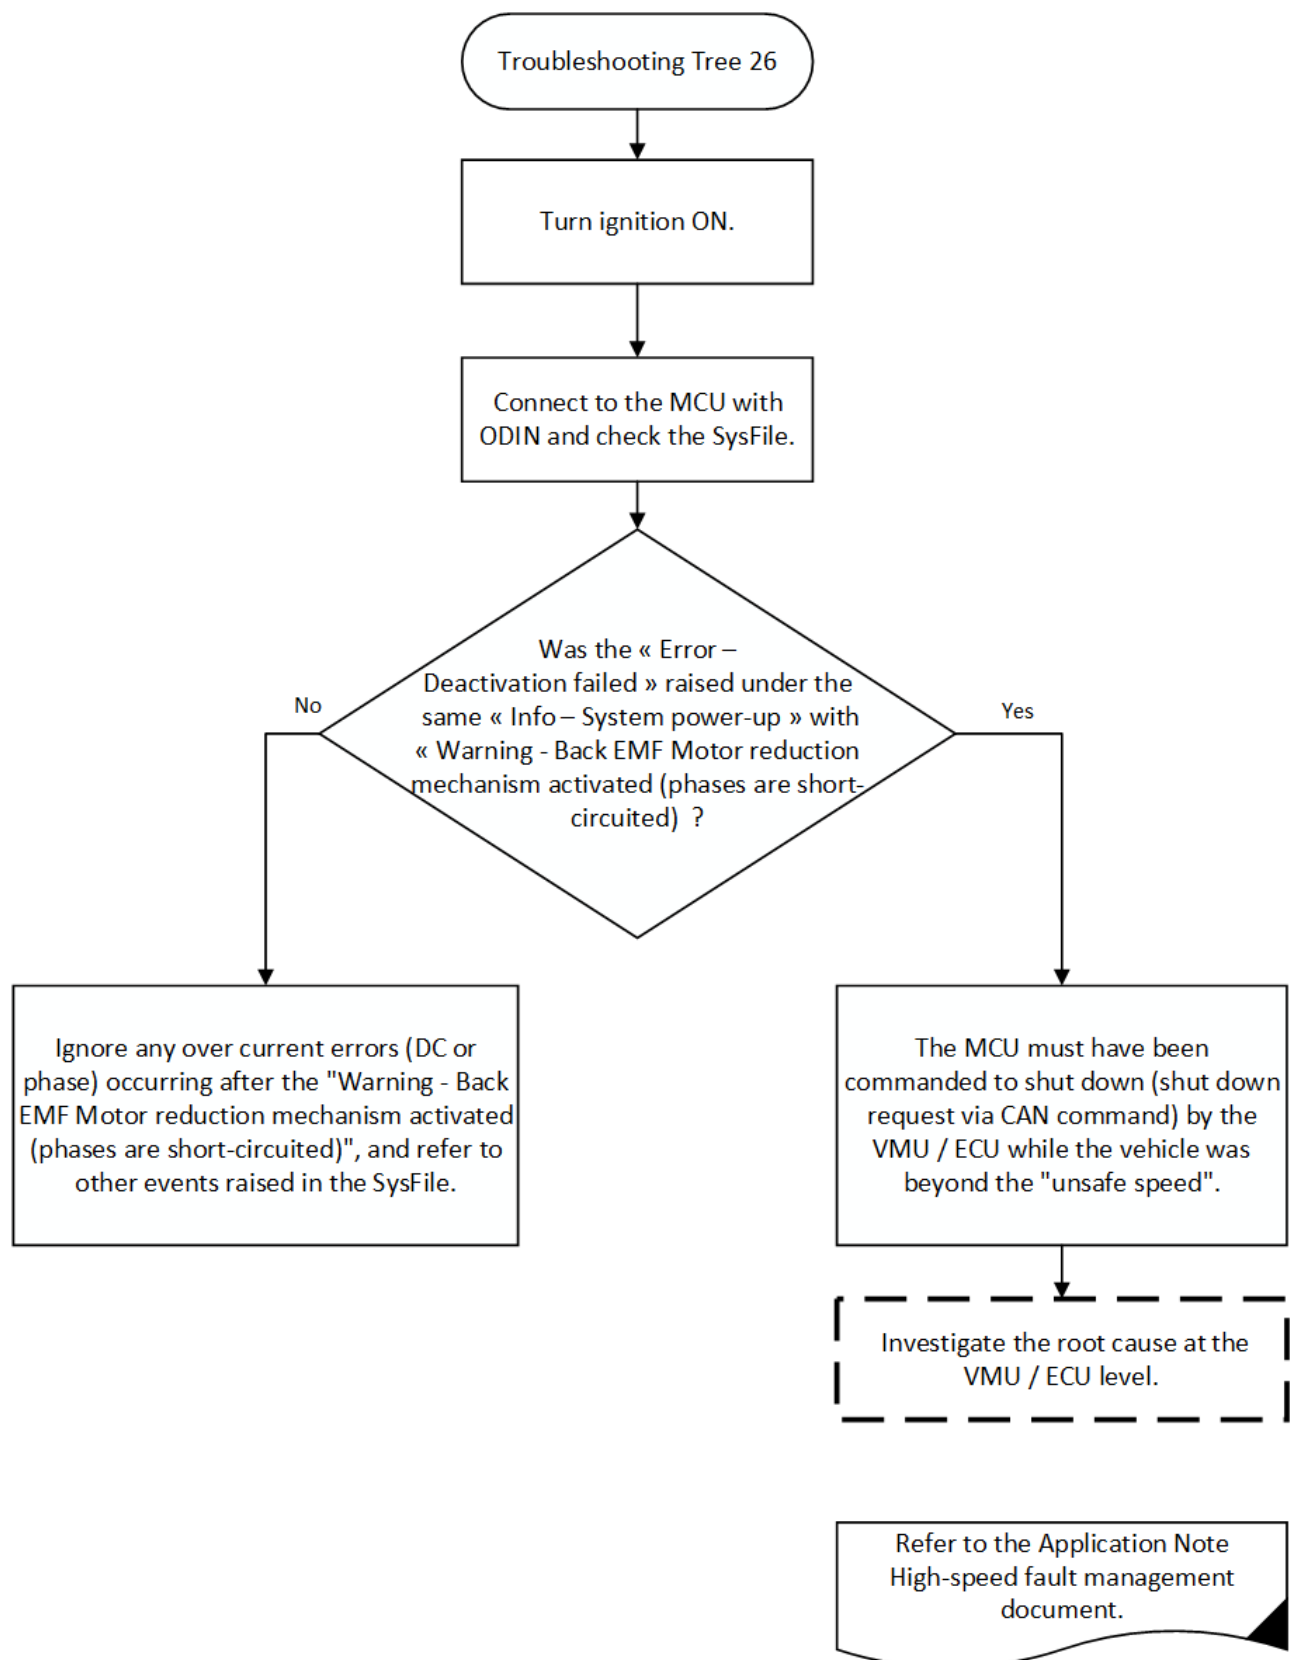
TT26: IGBT Short Circuit Activated

Any error event raised by the system while the motor speed is beyond the "unsafe speed" will activate the phase short circuit mechanism through the MCU power switch modules. This mechanism is activated to maintain the DC bus under the high voltage maximum limit until the motor speed is reduced under the « unsafe speed ».

To correctly diagnose the faulty system, connect the Diagnostic Tool (see «Diagnostics» section for test equipment and descriptions) and follow the troubleshooting tree procedure below.

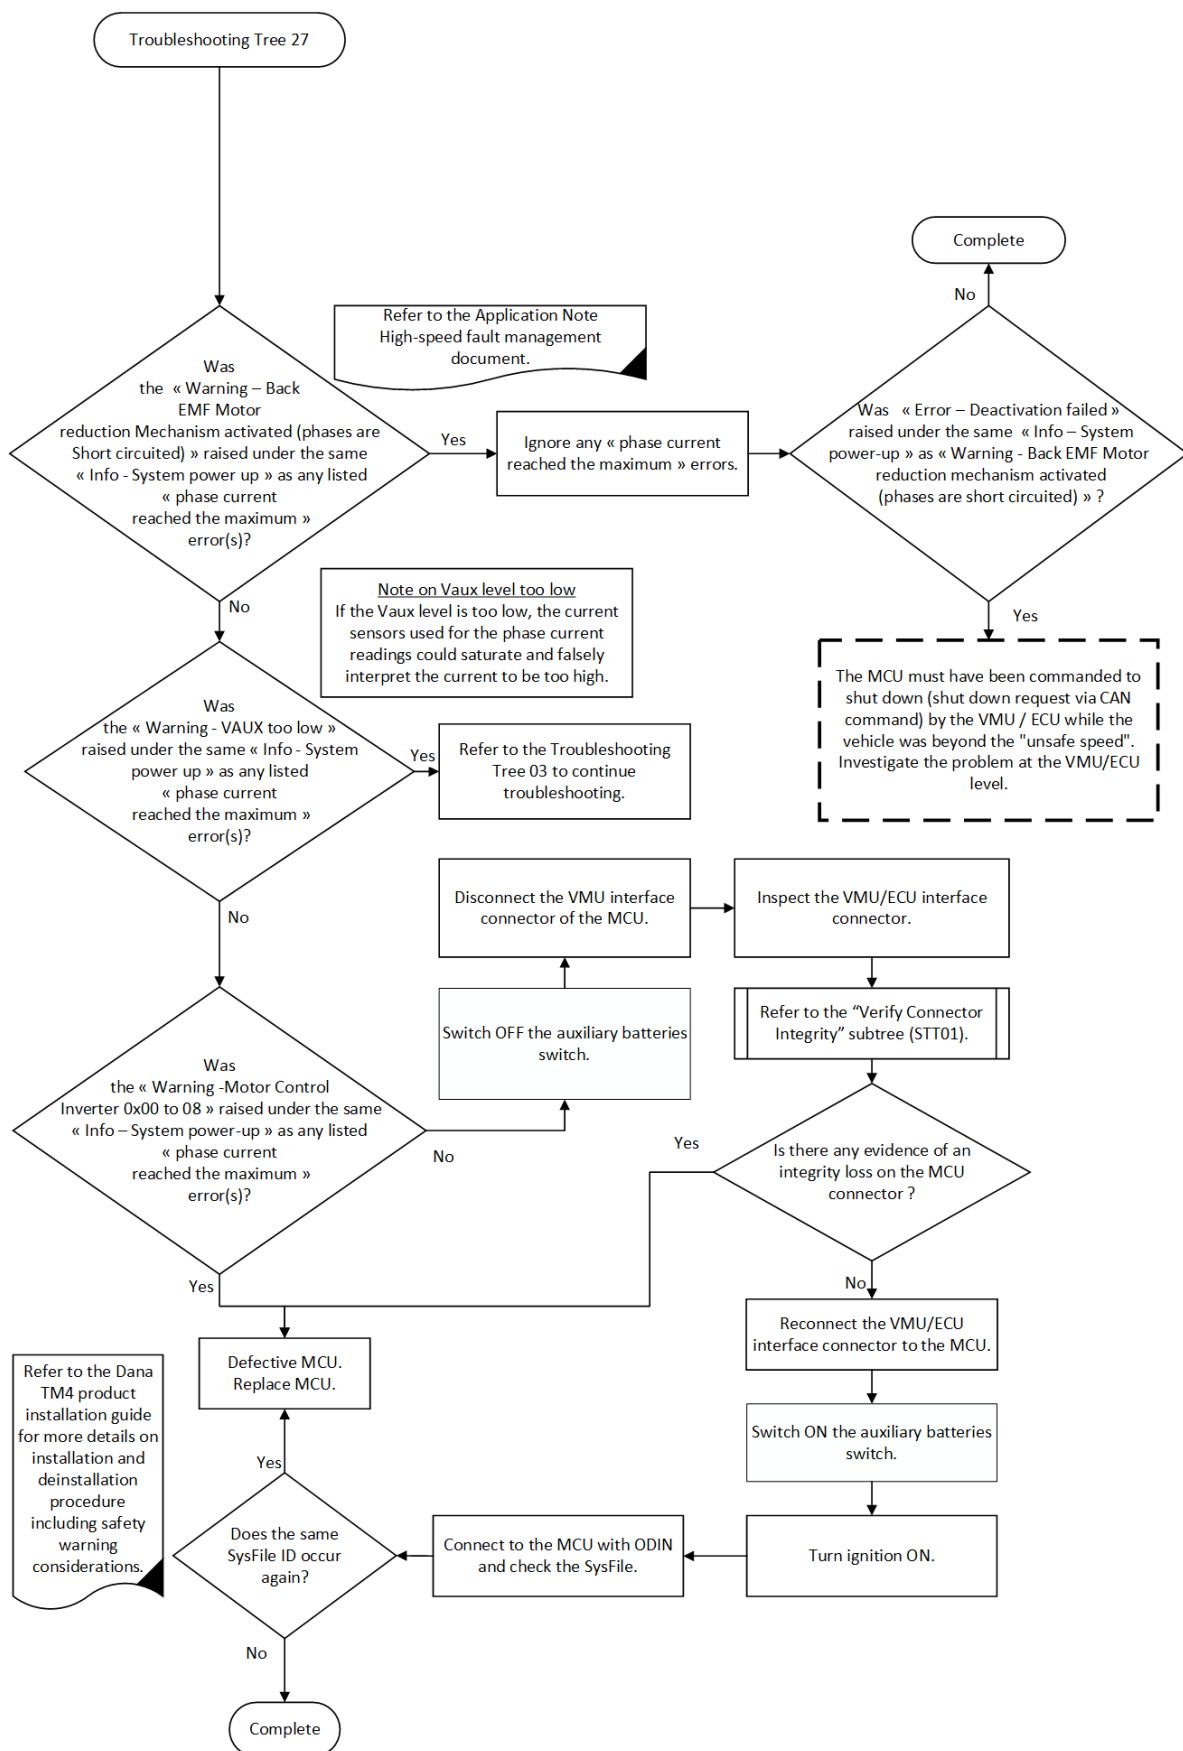
TT27: Phase Current reached Maximum

System Mode	Referred by SysFile ID	Condition	Possible Causes
Defective	0x3200 0x3201 0x3202 0x3204 0x3205 0x3206 0x3208 0x3209 0x320A	One or more of the phase currents reached the maximum design threshold.	<ol style="list-style-type: none"> 1. Short circuit between phases. 2. The auxiliary vehicle battery not operating correctly. 3. Intermittent or bad Vaux connection at the MCU. 4. Vaux Fuse about to open or more resistive. 5. An external error was caused by VMU/ECU. 6. Defective MCU.

To correctly diagnose the faulty system, connect the Diagnostic Tool (see «Diagnostics» section for test equipment and descriptions) and follow the troubleshooting tree procedure below.

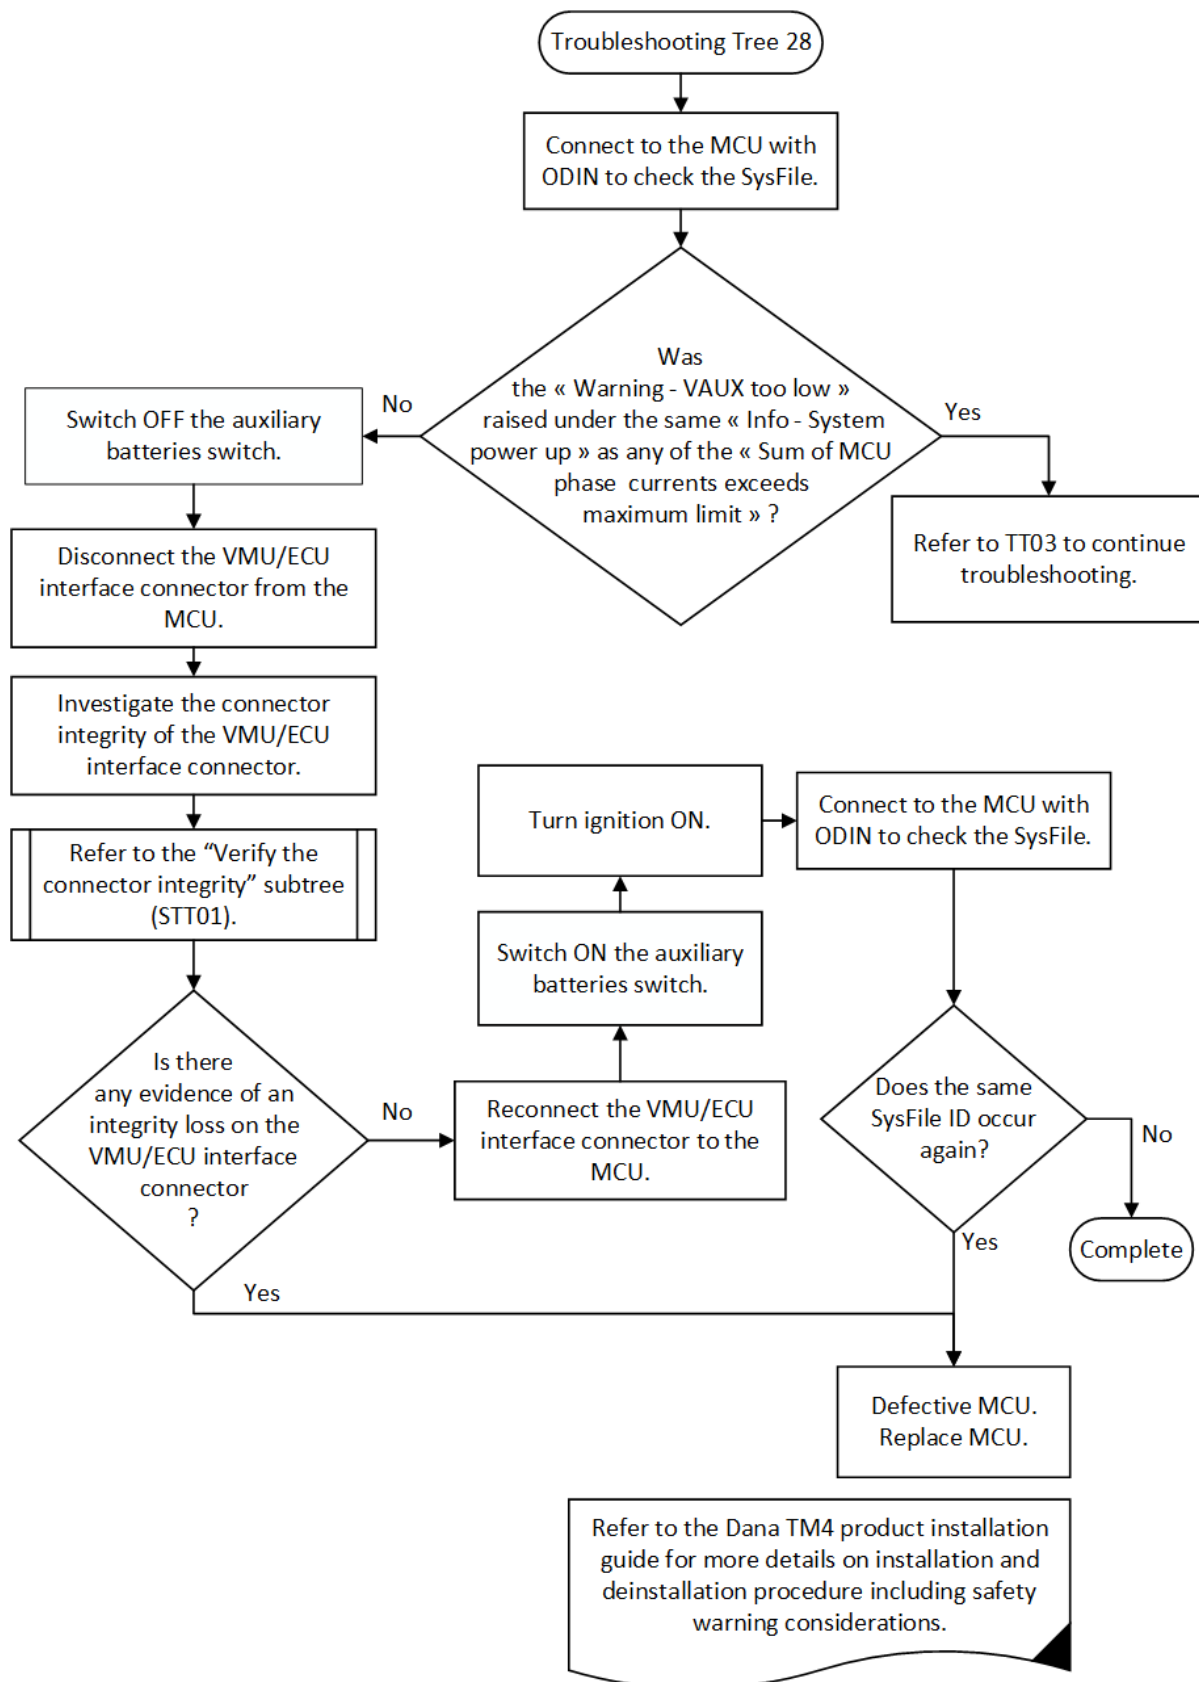
TT28: Phase Current Sum reached Maximum

System Mode	Referred by SysFile ID	Condition	Possible Causes
Operational	0x3203 0x3207 0x320B	The phase 1-2-3, 4-5-6, or 7-8-9 current sum reached the maximum limit.	<ol style="list-style-type: none"> 1. The auxiliary vehicle battery not operating correctly. 2. Intermittent or bad Vaux connection at the MCU. 3. Vaux Fuse about to open or more resistive. 4. Defective MCU.

To correctly diagnose the faulty system, connect the Diagnostic Tool (see «Diagnostics» section for test equipment and descriptions) and follow the troubleshooting tree procedure below.

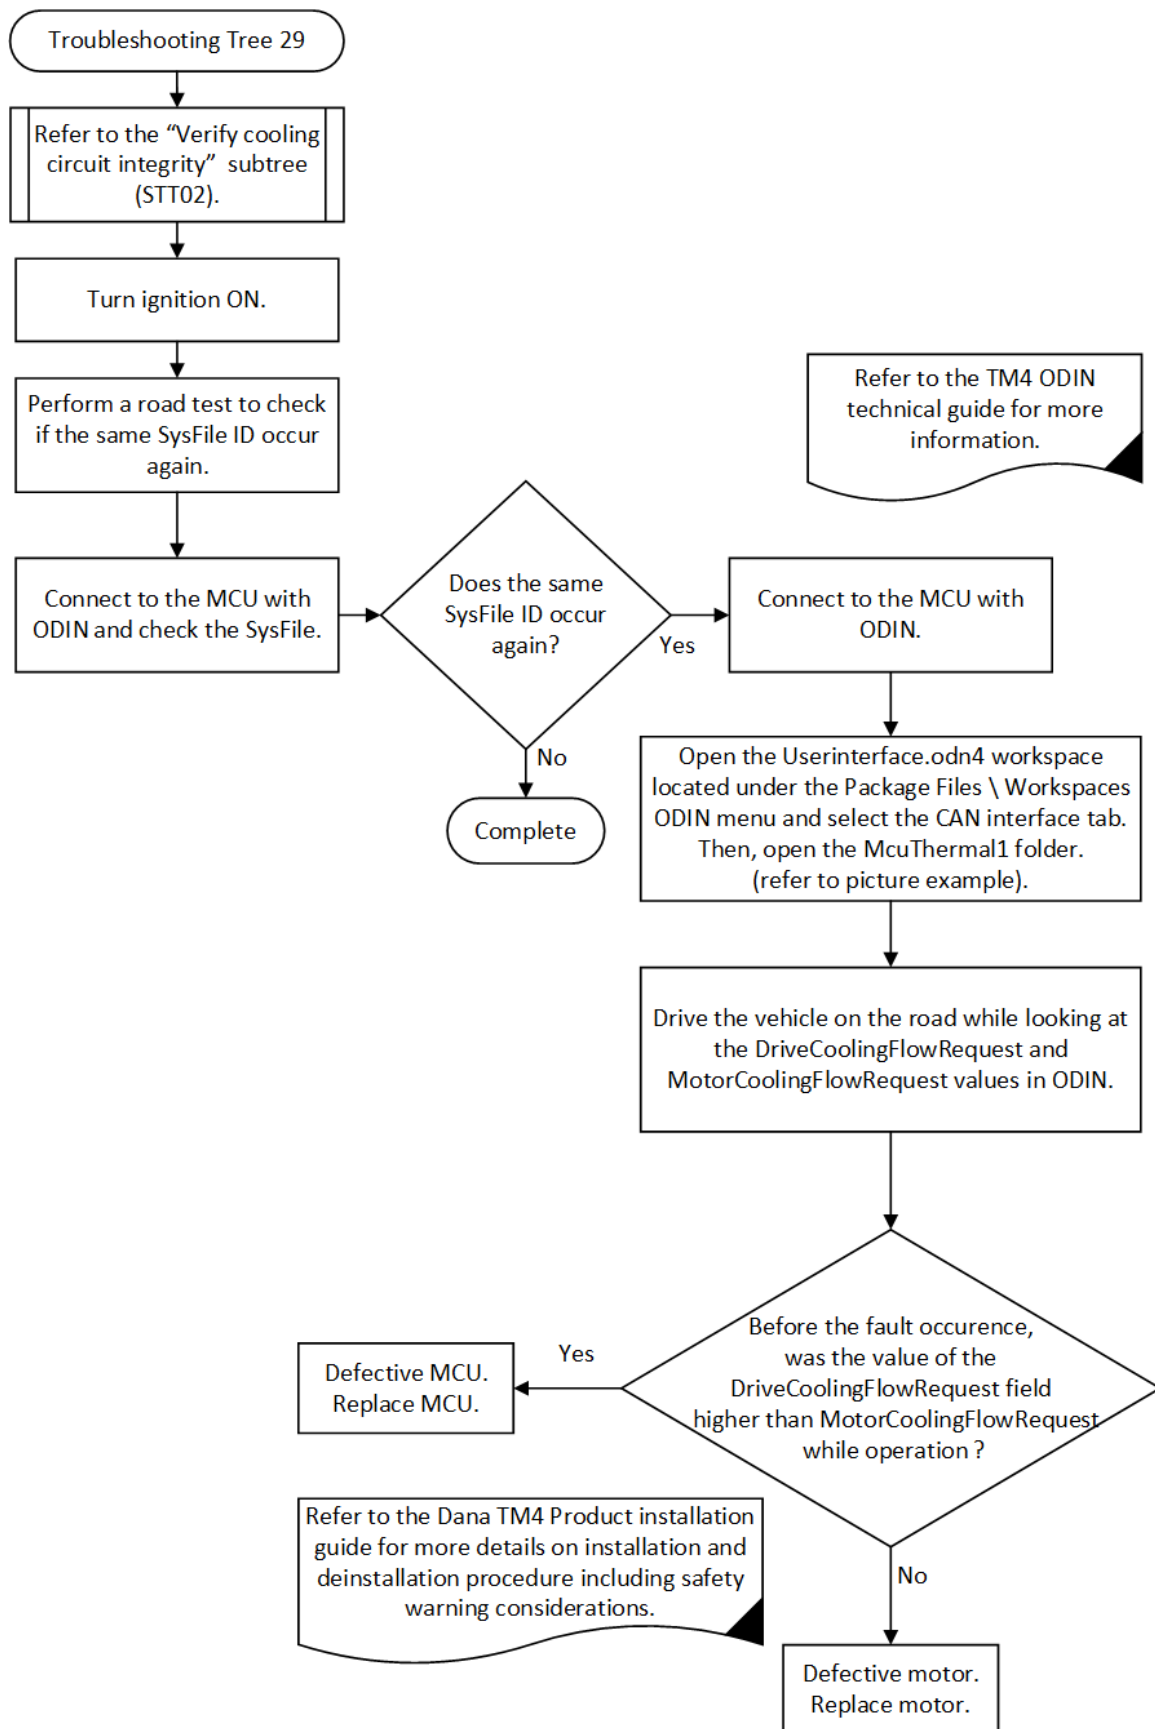
TT29: Insufficient Defluxing Current at high speed

A road test discriminates defective Motor and defective MCU from cooling circuit issue. Another road test discriminates the motor from the MCU defectives.

To correctly diagnose the faulty system, connect the Diagnostic Tool (see «Diagnostics» section for test equipment and descriptions) and follow the troubleshooting tree procedure below.

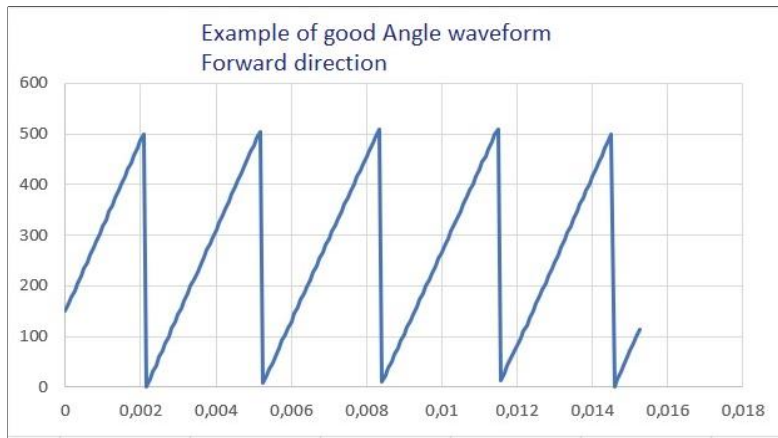
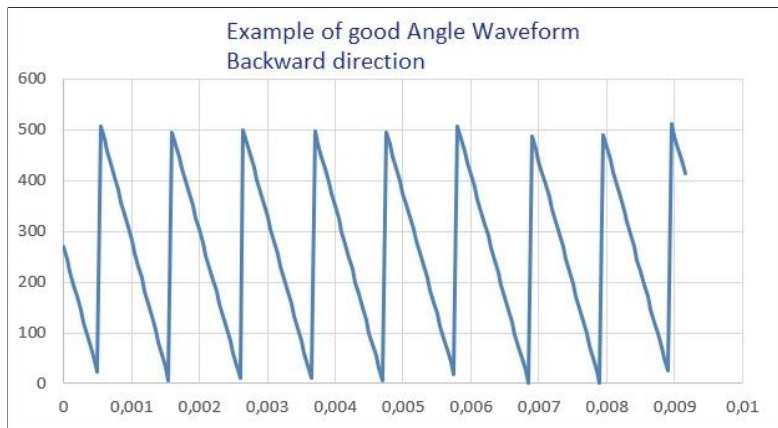
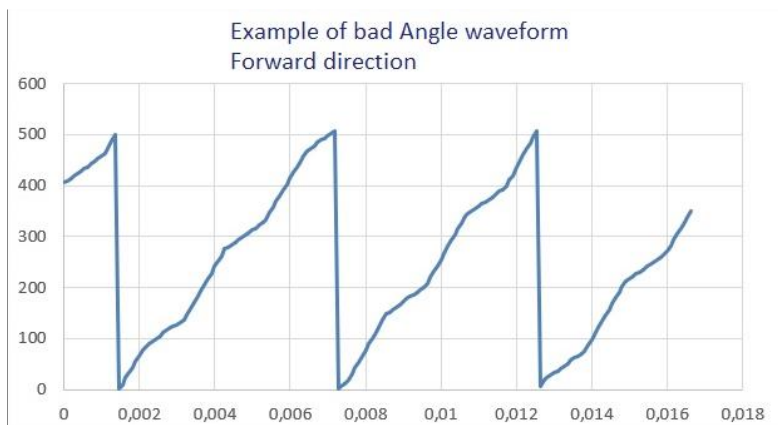
The BlackBox can then be consulted via ODIN tool to see if the angle waveform (saw tooth) is straight on each rising and falling edges.

See below examples of waveform.

Note: If the MCU goes in failure, it will capture a BlackBox upon the high voltage battery reached the high limit error. The BlackBox can then be consulted via ODIN tool to see if the angle waveform (saw tooth) is straight on each rise and fall edges.

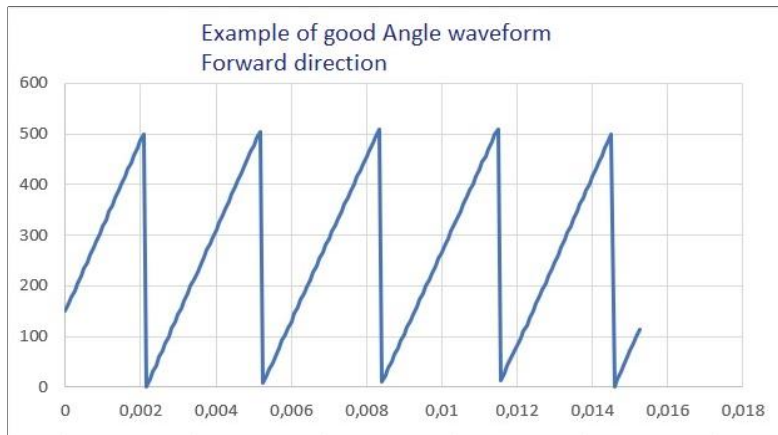
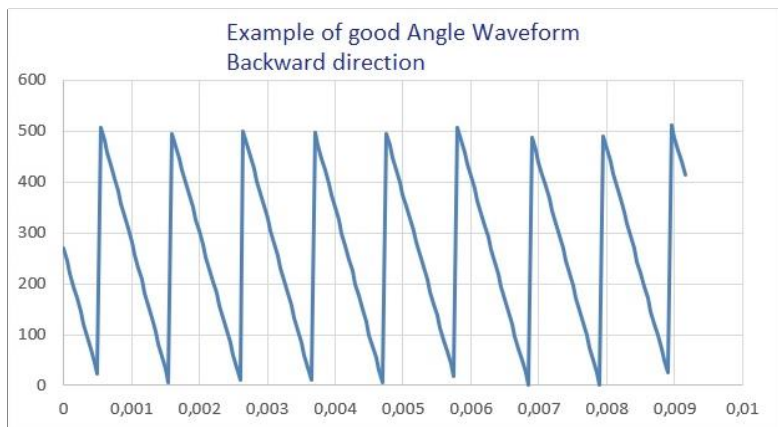
The BlackBox can then be consulted via ODIN tool to see if the angle waveform (saw tooth) is straight on each rising and falling edges.

See below examples of waveform.

Note: If the MCU goes in failure, it will capture a BlackBox upon the high voltage battery reached the high limit error. The BlackBox can then be consulted via ODIN tool to see if the angle waveform (saw tooth) is straight on each rise and fall edges.

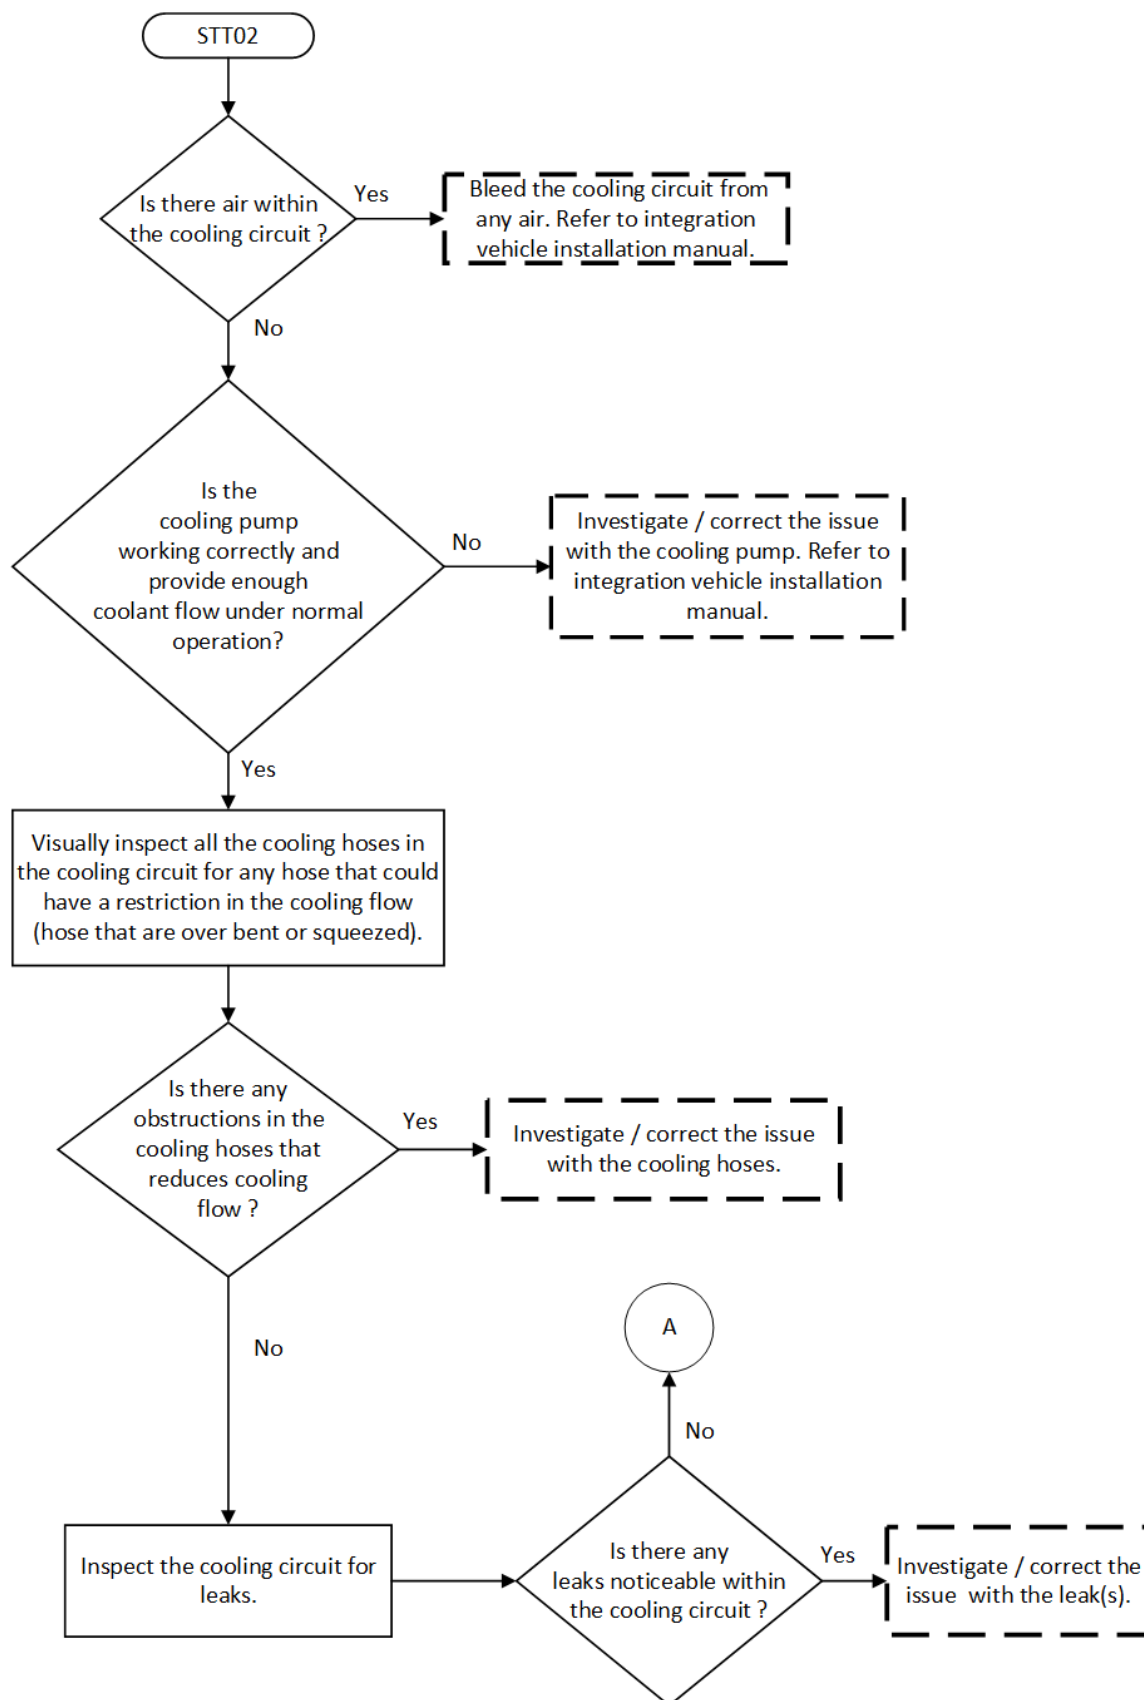
STT02: Verify Cooling Circuit Integrity

Related TT	External input	Outcome
TT20 TT21 TT22 TT23 TT24 TT29	None.	<ol style="list-style-type: none"> 1. The cooling system has no problems and can be left alone. 2. The cooling hoses have a problem and must be physically oved or replaced. 3. The coolant mixture is not the correct mixture, and it must be replaced. 4. There is an issue with the radiator.

The STT02 call the following process:

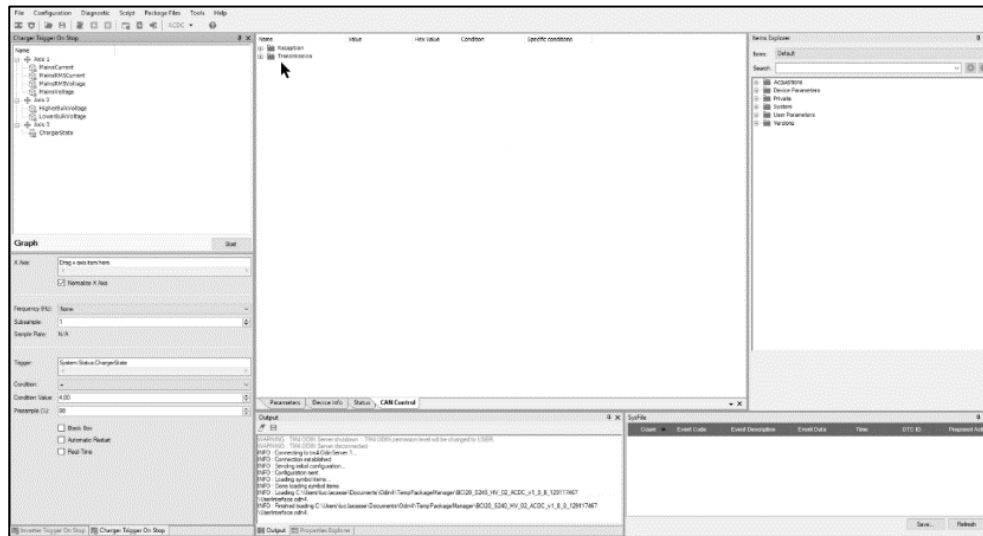
8. Wait until TM4 ODIN load the following page.

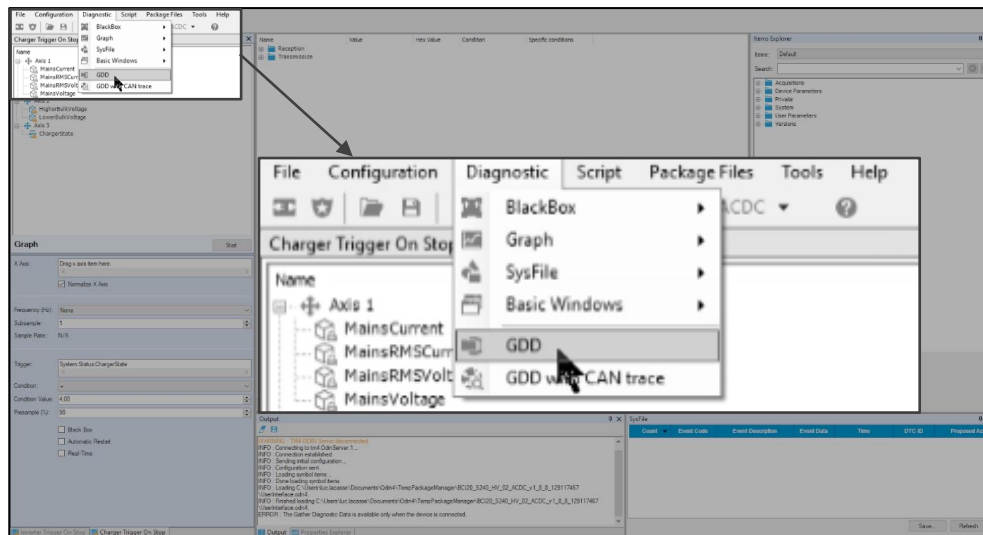
9. Make sure you are connected to the product using TM4 ODIN by checking that the bottom left of the Odin screen, « Device Connected » is displayed in green text.
10. In the « Diagnostic » dropdown menu, select « GDD ».

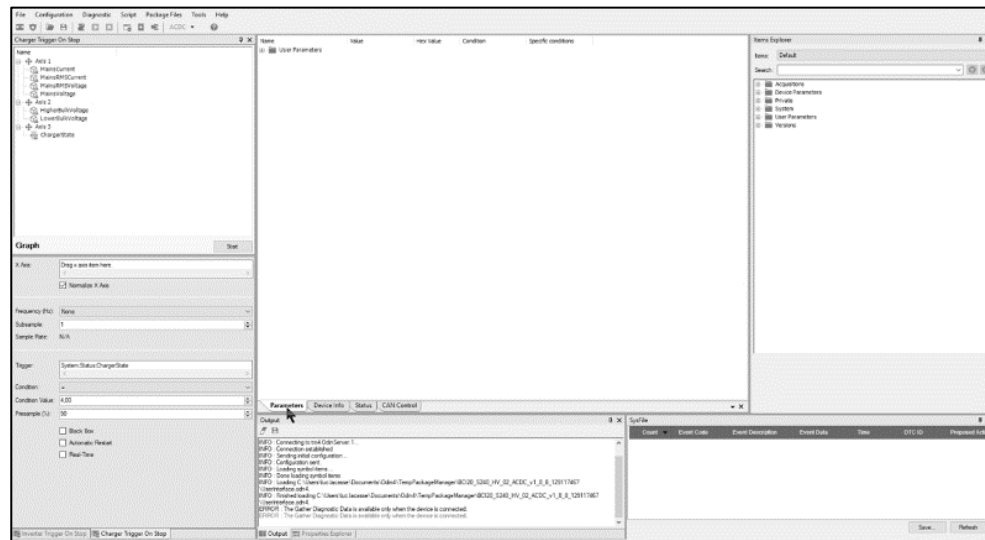
11. Wait until TM4 ODIN load the following page.

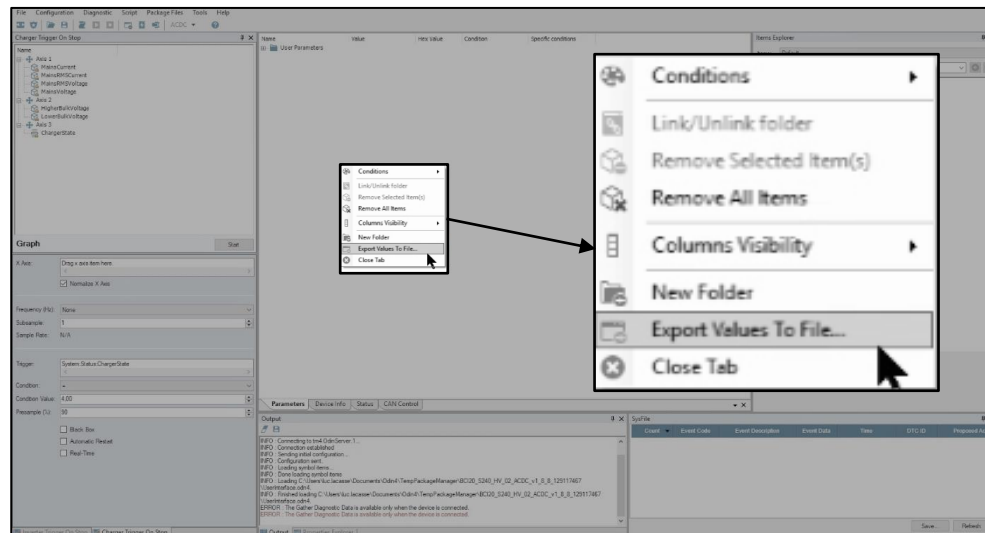
12. On the Parameters Tab, right click the select "Export Values To File..."
